Advanced Property Inspections

Home Inspection Report

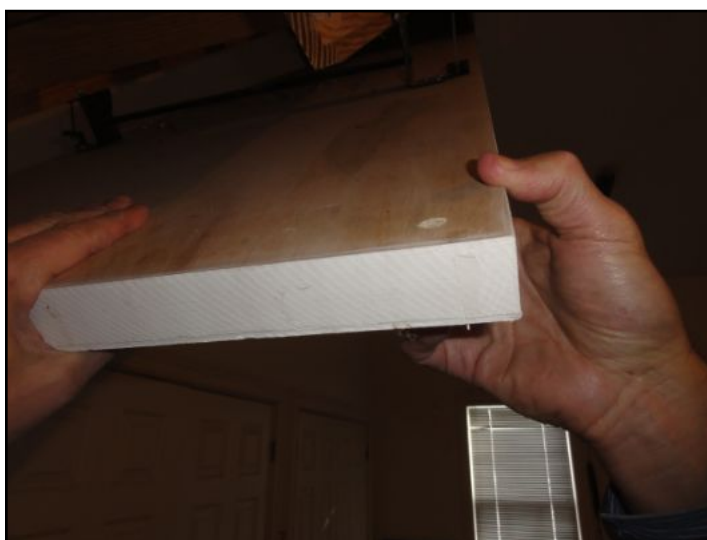
Inspector Comments The walls show several patches but are in acceptable condition in the areas that could be observed., **It appears the fire barrier between the garage and house has been broken by the installation of drop down attic stairs. Recommend correction by licensed contractor.**

Fire barrier broke with pull down steps

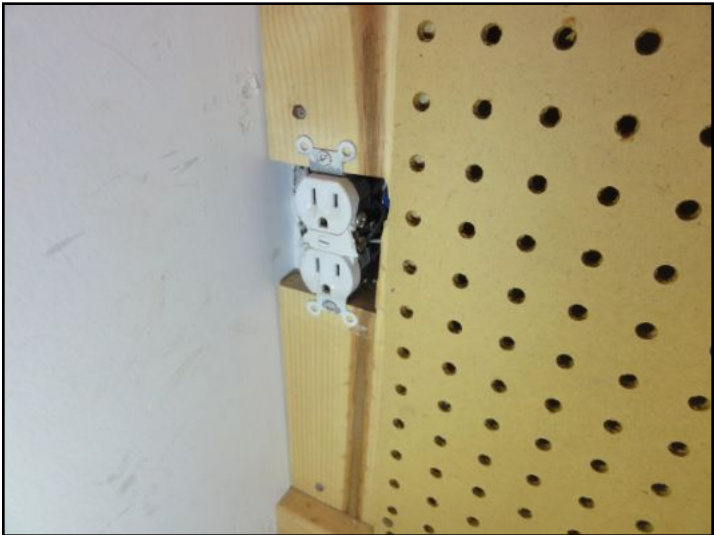
An outlet in the garage was missing a cover plate at the time of the inspection. This condition left energized electrical components exposed to touch. This shock/electrocution hazard should be corrected by a qualified personnel.

Missing outlet plate

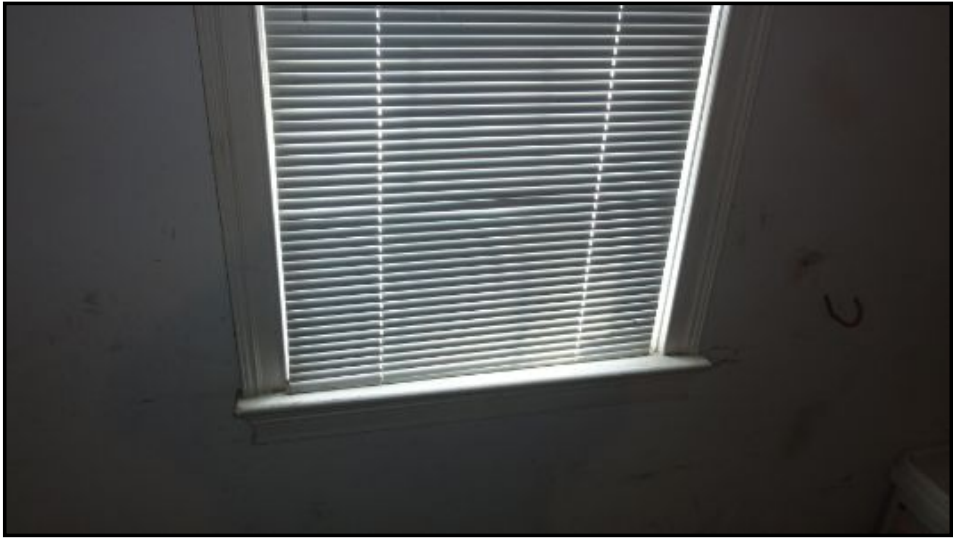
Observations: Garage window stuck in the closed position. Recommend correction by qualified personnel.

Garage window stuck

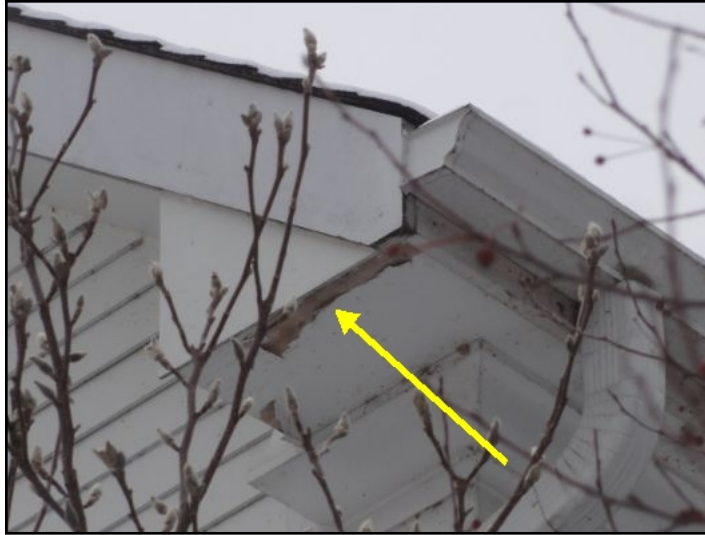
Small areas of wood trim need scraping and painting.

Peeled paint on soffit

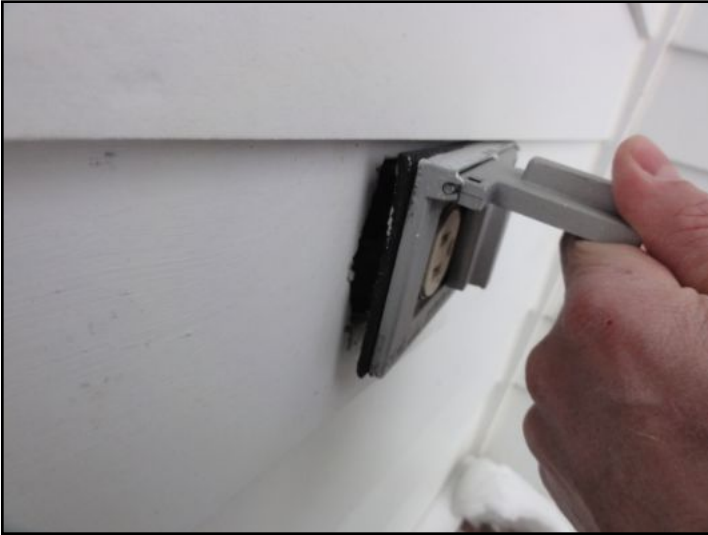
- Exterior light at back door didn't light. Try replacing bulb before consulting with licensed electrical contractor for repair.
- Exterior outlet was loose in the wall. Recommend repair by licensed electrical contractor.

Loose exterior outlet

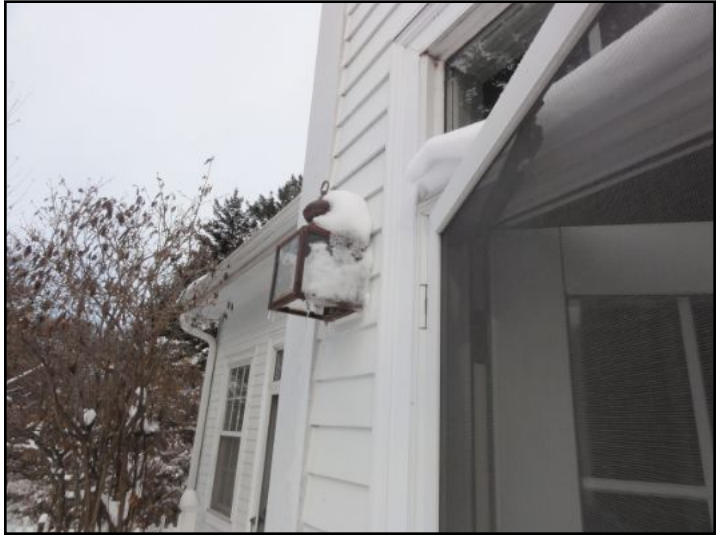
Light fixture at back door not lit

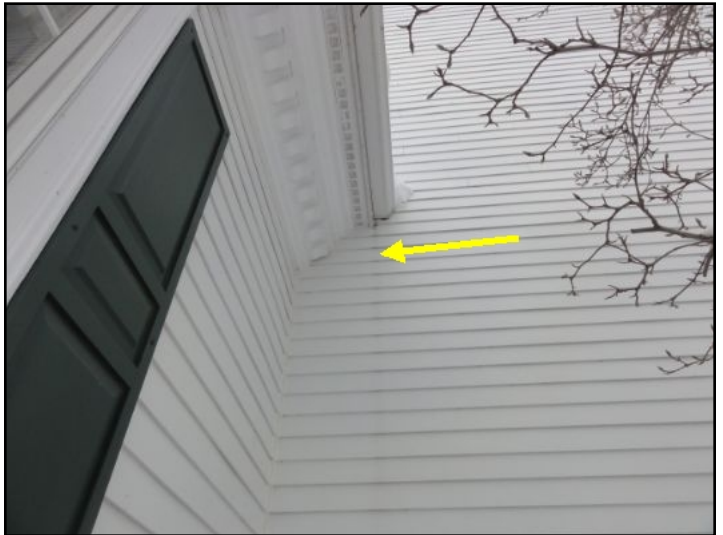
- The downspouts were drained to underground drain piping. Underground drain piping is outside the scope of a normal home inspection.
- There does not appear to be a kickout flashing where the gutter meets the wall. This allows water to run around the end of the gutter and down the fascia or wall. Recommend correction by licensed roofing contractor.

Gutter leaking down siding

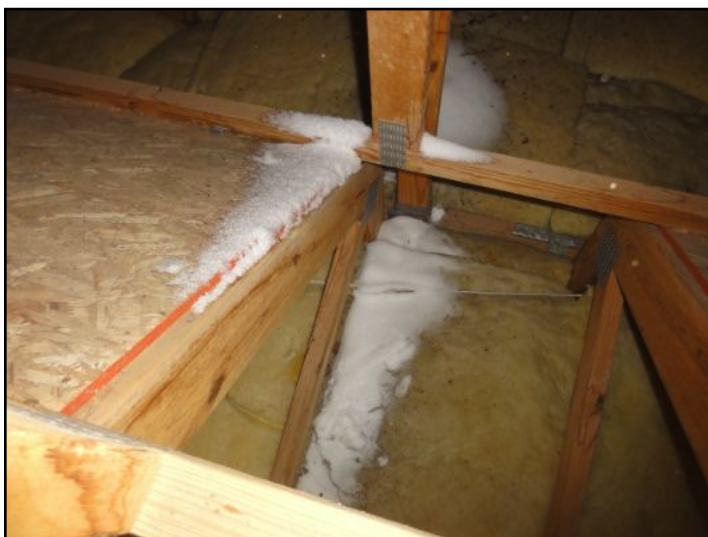
Snow blown through ridge vent

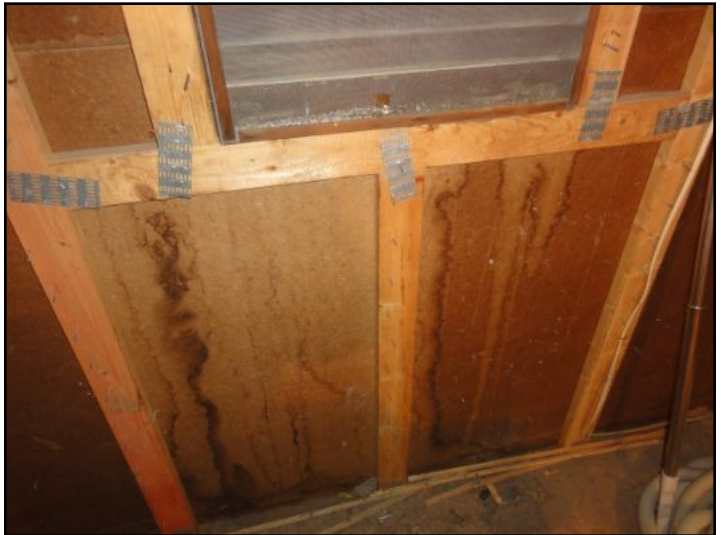
Garage attic moisture staining below gable vent

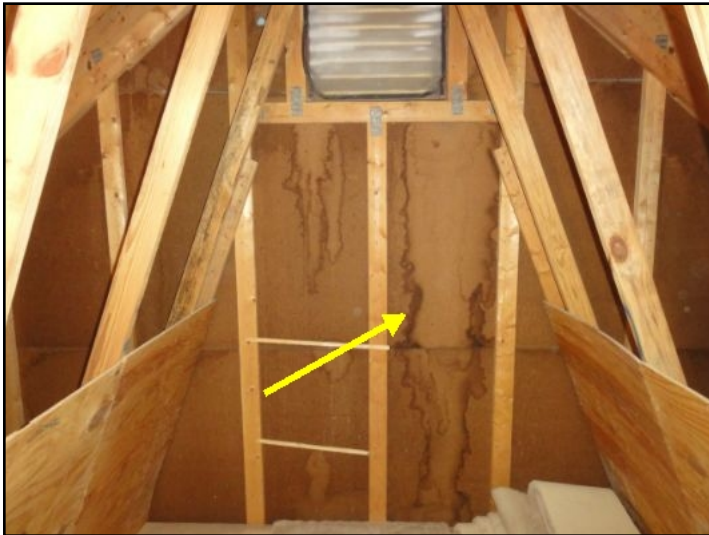
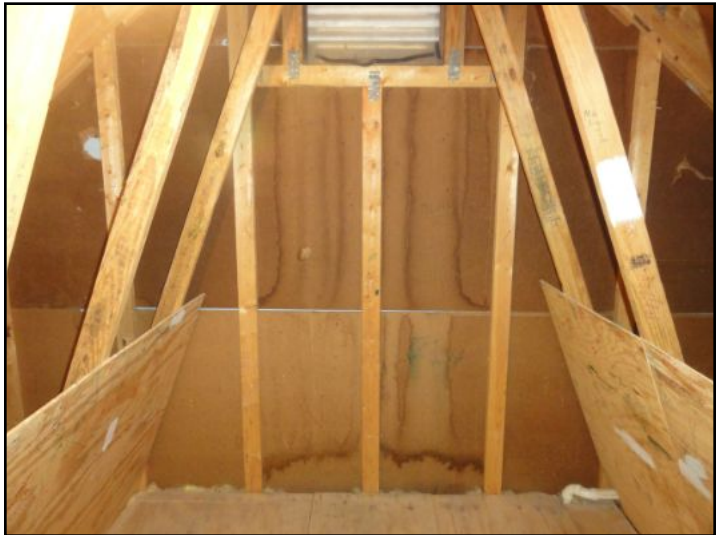
Inspector Comments Wall sheathing in the attic had areas of discoloration that appeared to be the result of moisture intrusion. Sheathing did not have elevated moisture levels at the time of the inspection. The source of the leaks may have been corrected or the freezing weather may be preventing water from entering at this time of year. Recommend evaluation by licensed contractor.

Moisture staining in attic

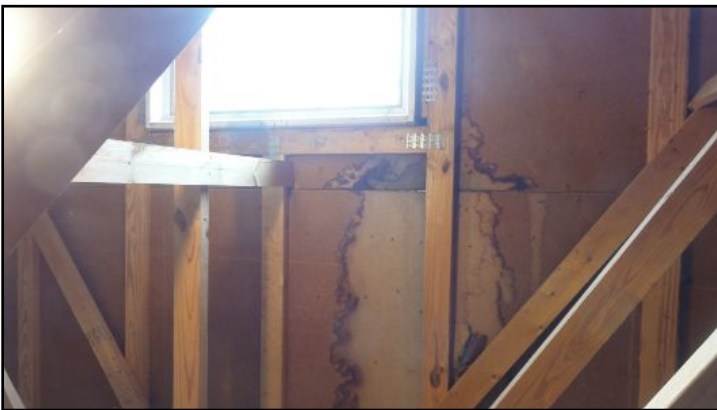
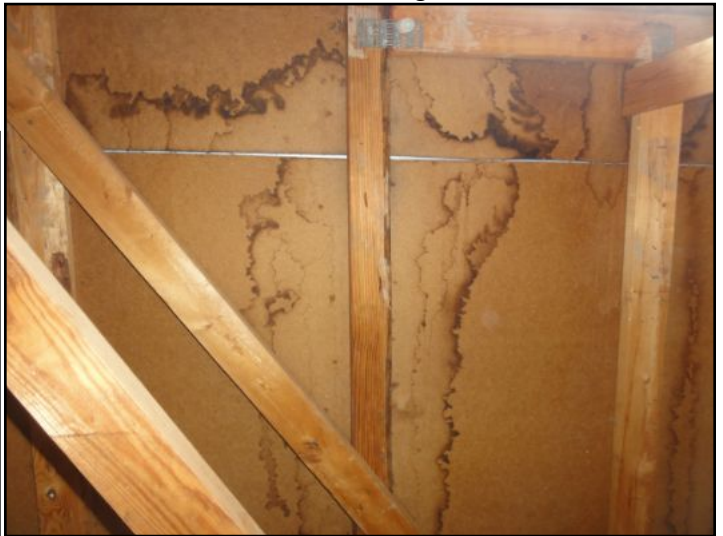
Moisture stains below attic window

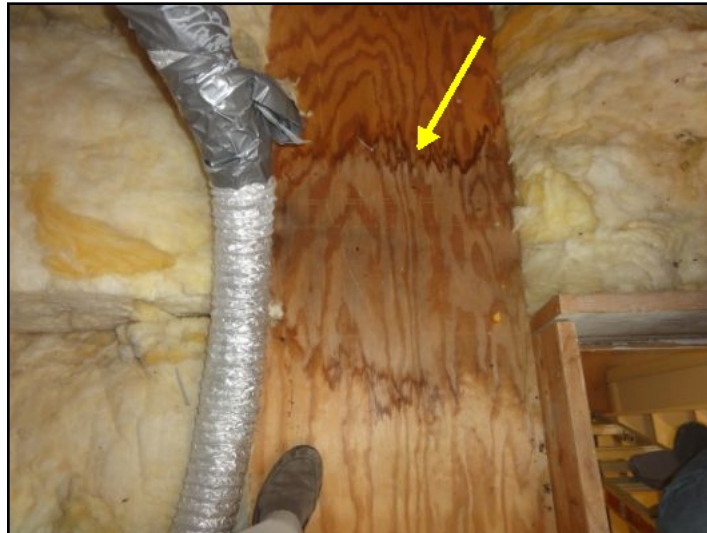
- Bathroom exhaust vents terminate outside as intended.
- Condensate appears to be leaking out of uninsulated bathroom vent pipe. If enough condensate leaks out it may result in staining of the interior ceiling or cause structural damage. Recommend qualified personnel insulate vent pipes in unconditioned spaces to prevent condensation.

Condensate leaking out of bath vent pipe

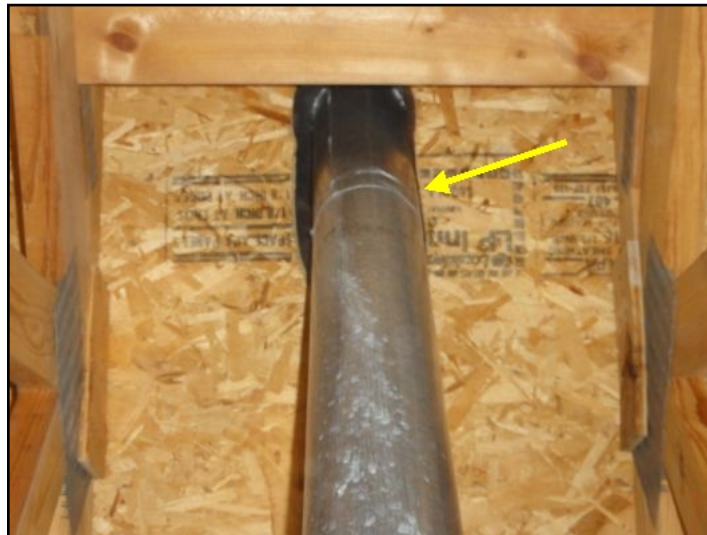
- Water heater flue pipe doesn't maintain one inch minimum clearance. Recommend the flue pipe be cleared by qualified personnel.

B-vent not maintaining 1" clearance

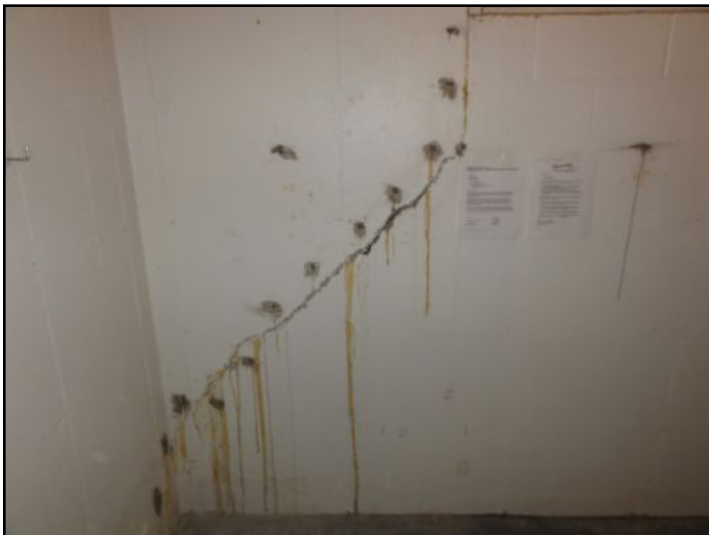
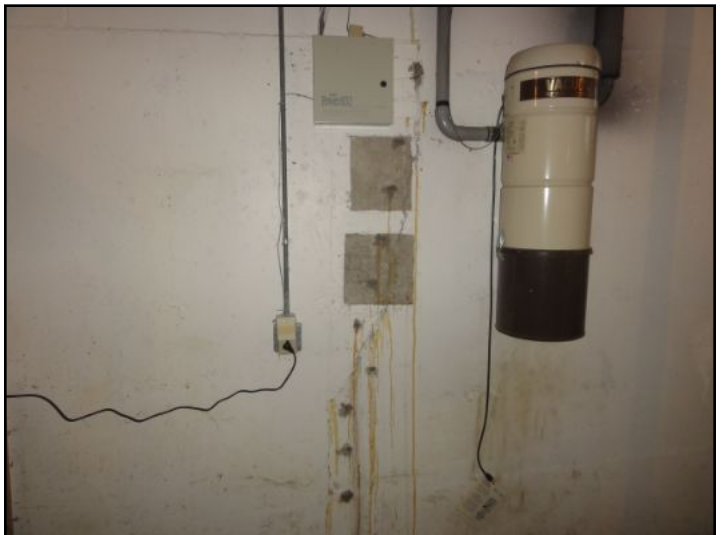
Observations: The Inspector observed few deficiencies during inspection of the poured concrete foundation walls. Notable Exceptions will be listed in this report. Two cracks were found that appeared to have had a professional repair performed on them.

Repaired crack in foundation wall

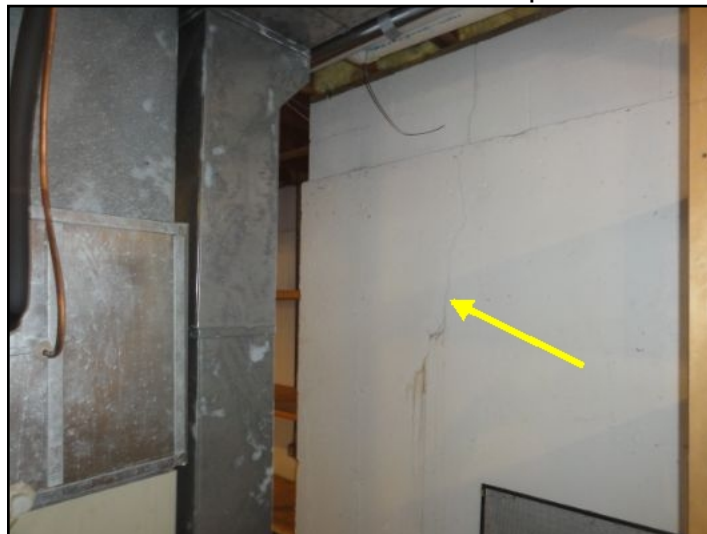
One crack about an 1/8" across in the poured concrete foundation wall appeared to be consistent with cracking caused by differential settlement. "Differential settlement" is the term used to describe portions of the foundation settling at different rates. Differential settlement creates stress on a foundation that is relieved by cracking. Differential settlement can be caused by the effects of moisture on certain types of soil, or by poor compaction at the time of original construction. If the crack was larger I might recommend evaluation by a foundation contractor, but the small size of the crack over the age of the home shows there is little movement. However, you should monitor this area and if any significant change occurs consult with a foundation specialist.

Crack in foundation wall

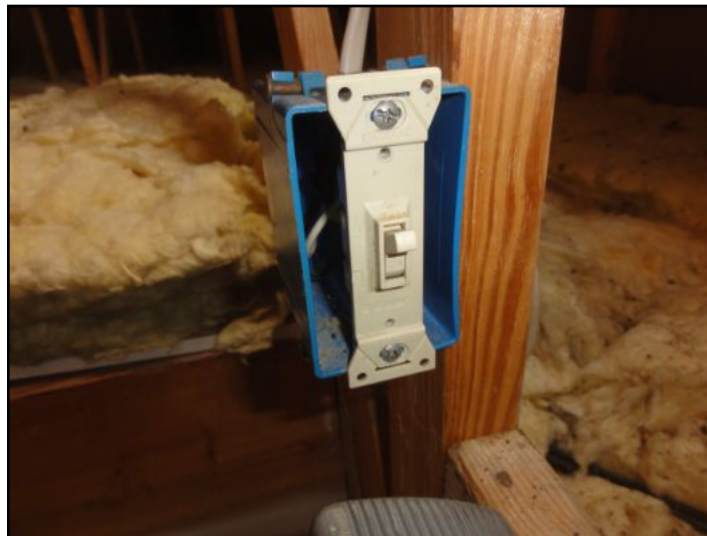
Observations: Missing switch cover in attic. This is a shock hazard. Recommend correction by qualified personnel.

Missing switch plate

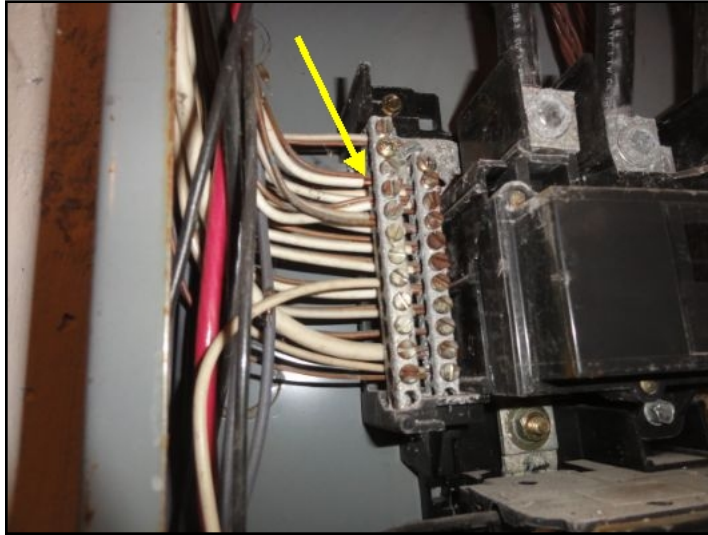
- Neutrals sharing lug on bus with another wire. While not SPECIFICALLY called out in the National Electrical Code until 2002, this has been a requirement by manufacturers markings as per NEC 110.3(b). While it doesn't appear the local authority with jurisdiction (building code inspector) enforces this, you should consider evaluation/repair by licensed electrical contractor.

Hots and neutrals sharing lug on buss

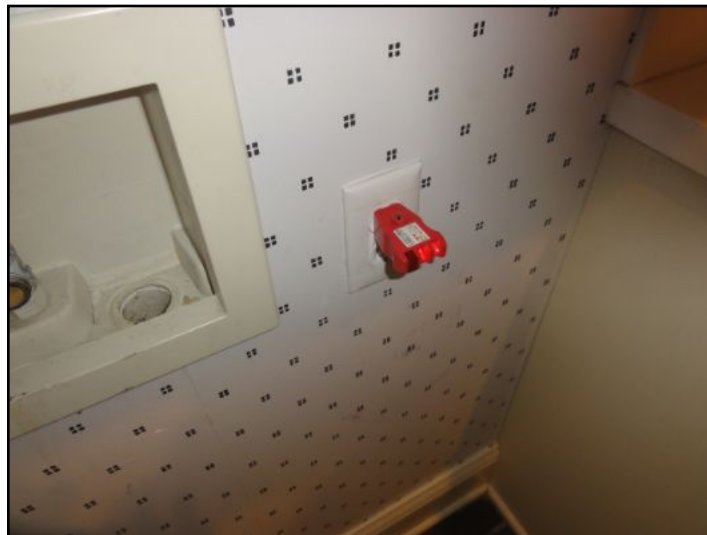
Inspector Comments Electrical outlet for washing machine appeared to be in serviceable condition at the time of the inspection but had no Ground Fault Circuit Interrupter (GFCI) protection. Although this condition may have been commonly considered safe or acceptable at the time the home was originally constructed, as general knowledge of safe building practices has improved with the passage of time, building standards have changed to reflect current understanding. Consider having GFCI protection installed as a safety precaution. This can be achieved by:

Recommend GFCI protected outlet for washer

1. Replacing the current standard outlets with GFCI outlets
2. Replacing the outlet in this circuit which is nearest the main electrical service panel with a GFCI outlet.
3. Replacing the breaker currently protecting the electrical circuit which contains these bathroom outlets with a GFCI breaker.

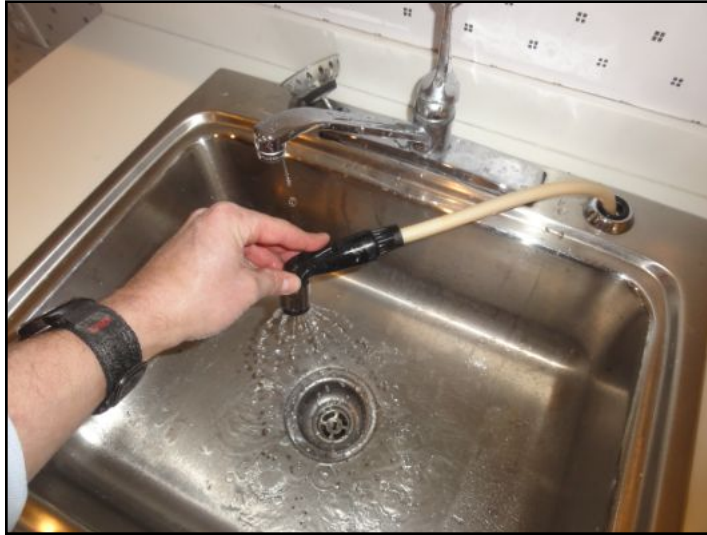
- The laundry room sink appeared to be in serviceable condition at the time of the inspection.
- The laundry room sink had functional drainage at the time of the inspection.
- Faucet wand did not shut off when tested. Recommend wand be repaired/replaced by qualified personnel.

Wand doesn't shut off

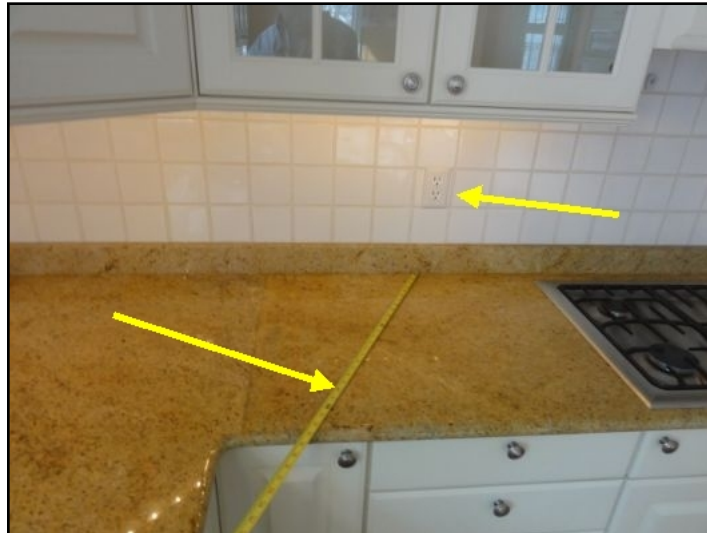
Non-GFCI protected outlet within six feet of kitchen sink. Recommend upgrade to GFCI protected outlet for safety.

Non-GFCI protected outlet within six feet of sink

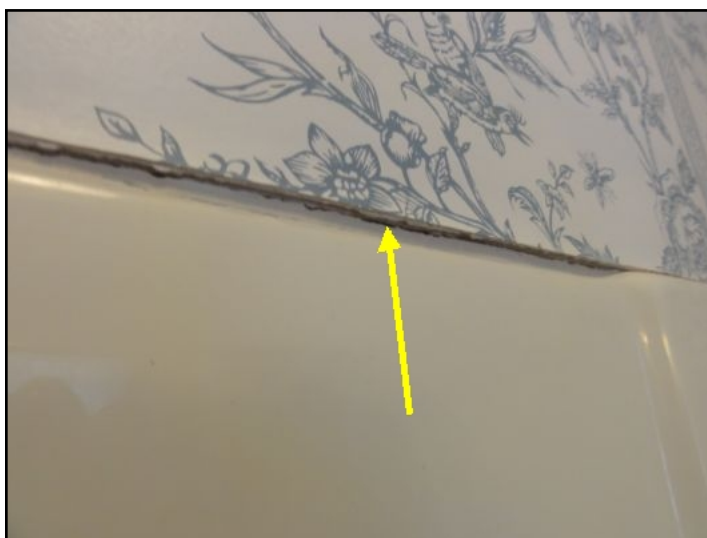
- Caulk is missing or deteriorated at the bathtub. It should be replaced where deteriorated and/or applied where missing to prevent water intrusion and damage to the wall structure.

Caulk needed at shower enclosure to wall board

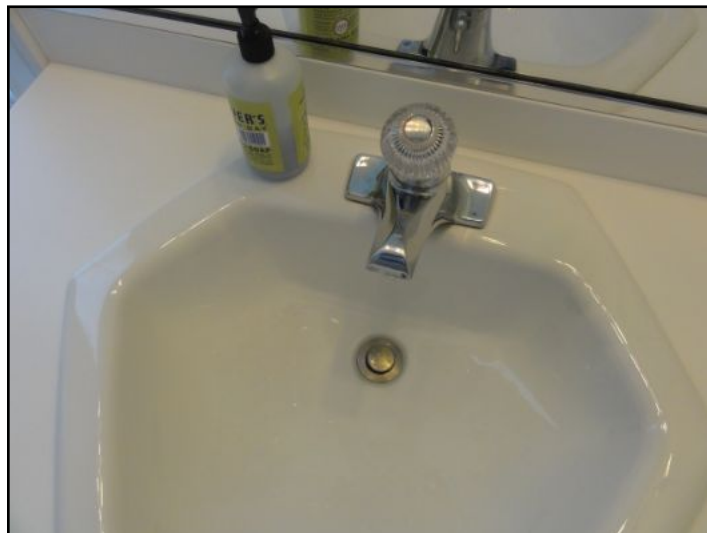
- This bathroom sink appeared to be in serviceable condition at the time of the inspection.
- The bathroom sink faucet appeared to be in serviceable condition at the time of the inspection.
- The bathroom cabinets and counter top were serviceable at the time of the inspection.
- The sink in this bathroom had an inoperable stopper.

Faucet stopper needs repair

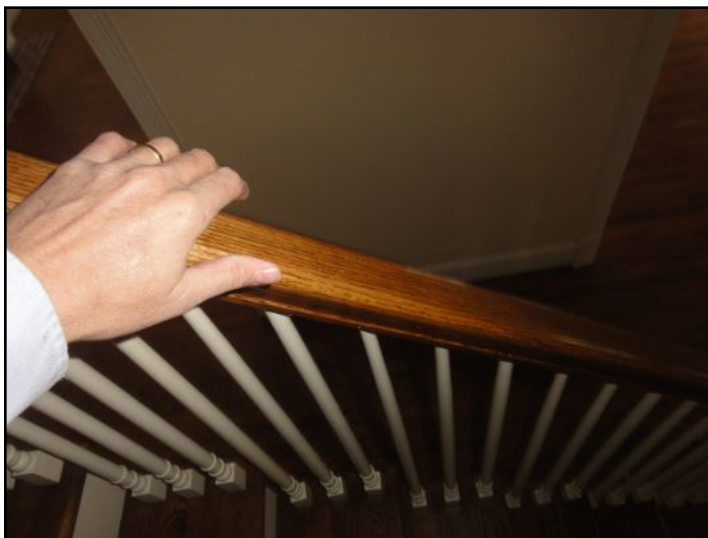
- Inspector Comments** Upstairs handrail loose. Handrails should be able to withstand a 200 pound load in any direction. Recommend correction buy licensed contractor. Handrail doesn't meet minimum height requirement of 34 inches from stair toe to top of handrail. Recommend consultation with licensed contractor to evaluate options.

Handrail for stairway to upper level loose

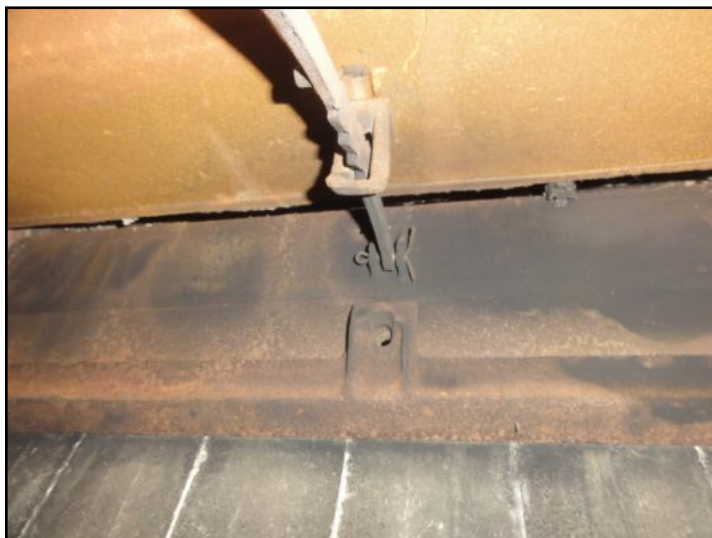
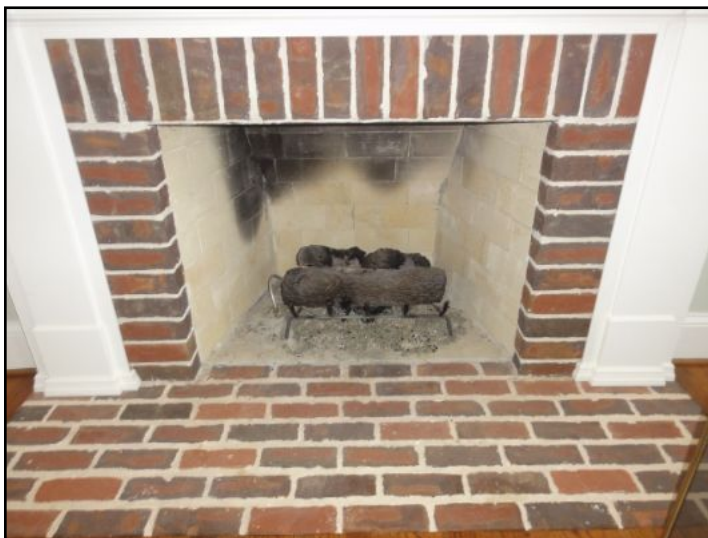
- The den had a gas-fueled fireplace.
- The gas fireplace in the den appeared to have the gas turned off and was not operated. The Inspector recommends an examination of this fireplace and any necessary work be performed by a qualified contractor.
- The gas-fired fireplace in the den had an operable damper. Because the toxic products of gas combustion are not visible to the human eye, if the damper were closed while the fireplace was in operation, dangerously high levels of toxic exhaust gas could accumulate in the home. The damper should be fixed in an open position in a manner that will not allow it to be closed.

Gas fireplace has closeable damper

Gas fireplace appears to have gas shut off.

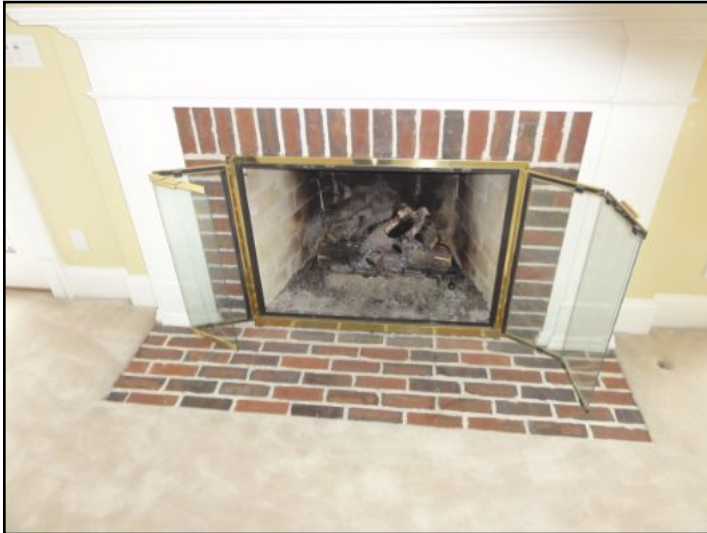
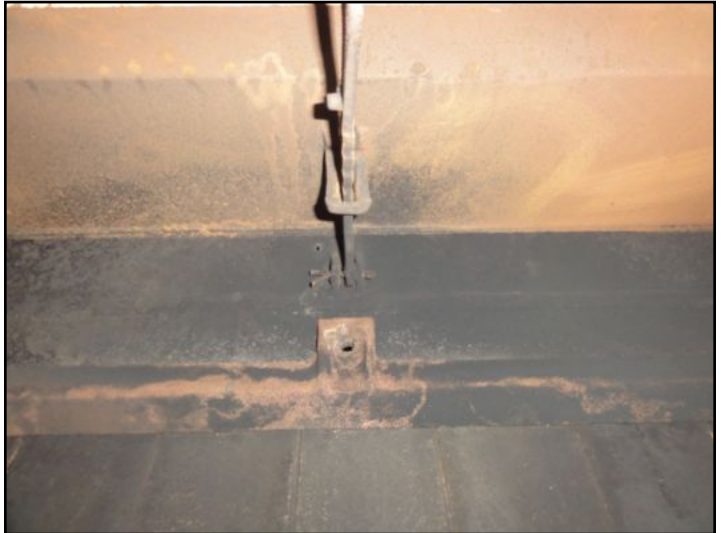
The gas-fired fireplace in the family room had an operable damper. Because the toxic products of gas combustion are not visible to the human eye, if the damper were closed while the fireplace was in operation, dangerously high levels of toxic exhaust gas could accumulate in the home. The damper should be fixed in an open position in a manner that will not allow it to be closed.

Pilot not lit in family room fireplace

Closeable damper in family room gas fireplace

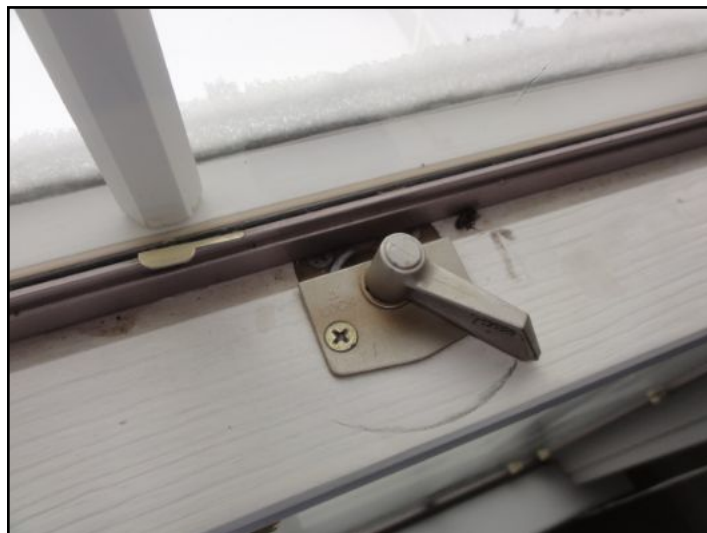
Observations: Most windows in the bedrooms were wood and double hung. Three windows in the master bedroom couldn't be locked because of misalignment of the latching mechanism. Recommend correction by qualified personnel.

Three windows in master bedroom don't lock properly
