Advanced Property Inspection

Home Inspection Report

9733 Easy St, kenosha, WI 53144
Inspection prepared for: Buyer Home
Real Estate Agent: -

Date of Inspection: 3/26/2021 Time: 8:30 AM
Age of Home: 1991 Size: 1971 Sq Ft
Weather: 34F Cloudy
Order ID: 1885

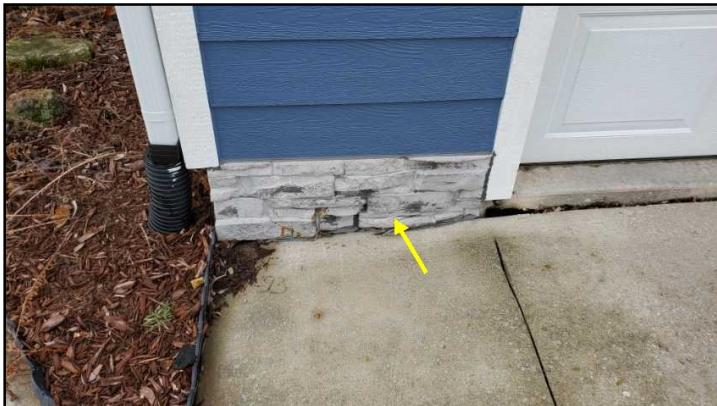
- The exterior walls of the house were covered with composite siding, masonry
- Manufactured stone veneer has been installed on the home. An inspection of the visible components has revealed that the stone veneer has not been installed in compliance with installation guidelines provided by the Masonry Veneer Manufacturer's Association (MVMA). The MVMA guidelines are available at <http://ncma-br.org/pdfs/masterlibrary/MVMA%20Installation%20Guide%204th%20Edition%20web.pdf>. Specific problems noted with the visible components include, but may not be limited to:

Manufactured stone veneer

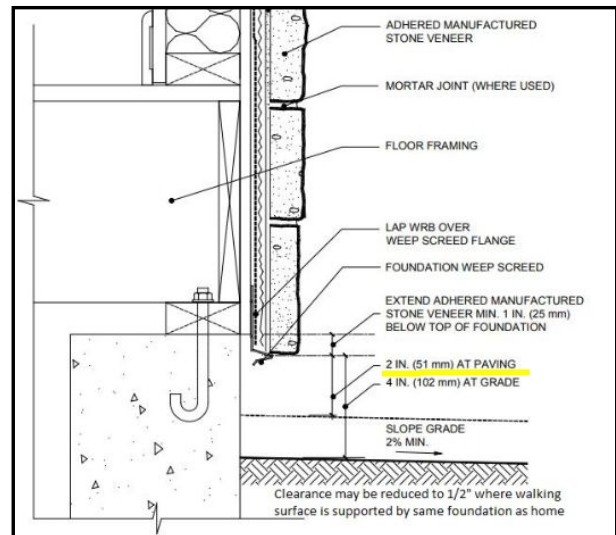
The masonry veneer had insufficient clearance to paved surfaces

The lack of proper detailing and flashing may result in water penetration behind the stone veneer, resulting in structural damage or the development of unhealthy conditions such as mold. The installation of the manufactured stone veneer should be evaluated, compared to the specific installation requirements of the stone manufacturer and the MVMA, and repaired or replaced as deemed necessary by a licensed general contractor or masonry contractor experienced with installation requirements for manufactured stone veneer. Please note that because the water resistive barrier, metal lath, and base coat(s) of cement stucco are completely concealed behind the manufactured stone veneer, they cannot be evaluated by a non-invasive visual inspection.

Stone veneer clearance to paving

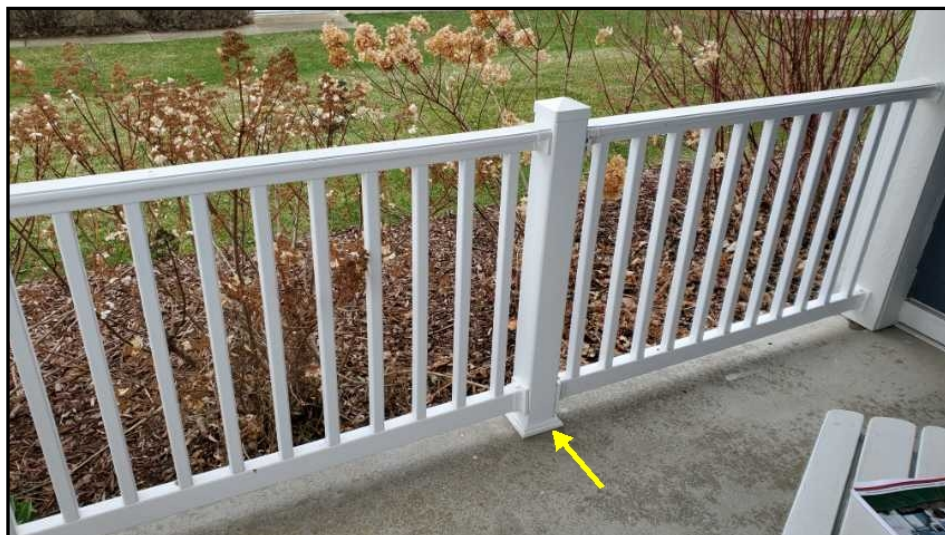
- Front porch guardrail loose.

Guardrail loose

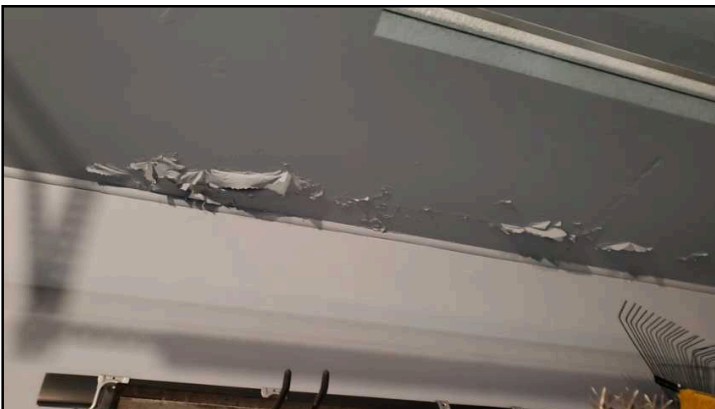
Peeling paint on ceiling

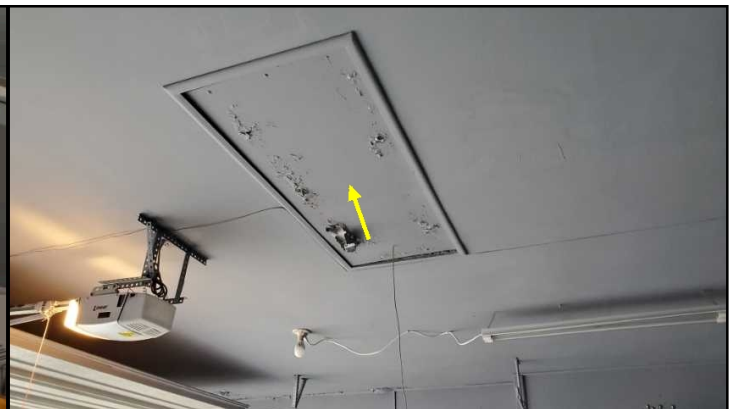
- The visible walls and ceiling were in acceptable condition in the areas that could be observed.
- Modern homes use a layer of non-combustible drywall between the garage and home to prevent fire from spreading from garage to the home. The fire barrier between the garage and house has been broken. Recommend correction by licensed contractor.
- Peeling paint on ceiling.

Fire barrier between garage and house broken

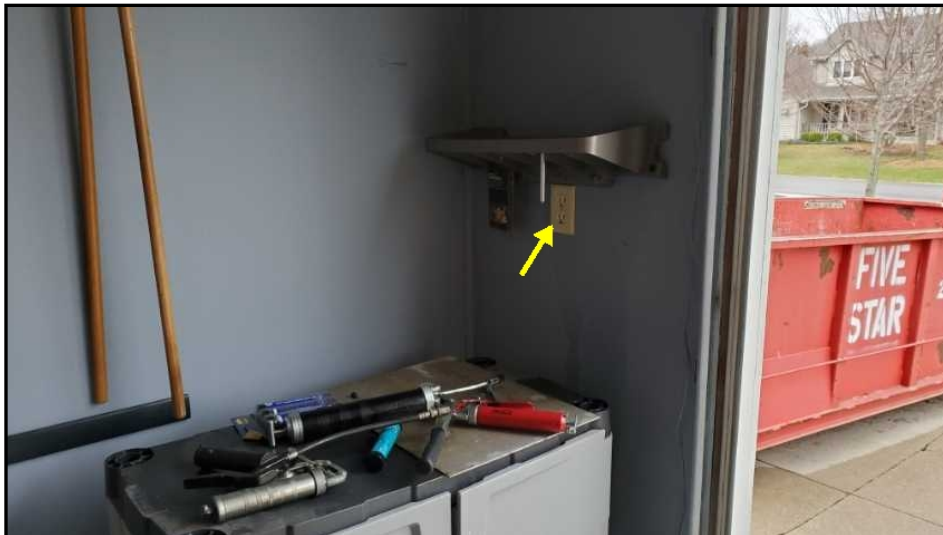
- An electrical outlet in the garage had no Ground Fault Circuit Interrupter (GFCI) protection which has been required in the national electric code since 1978. I recommend a licensed electrical contractor install GFCI protection.

Failed GFCI testing

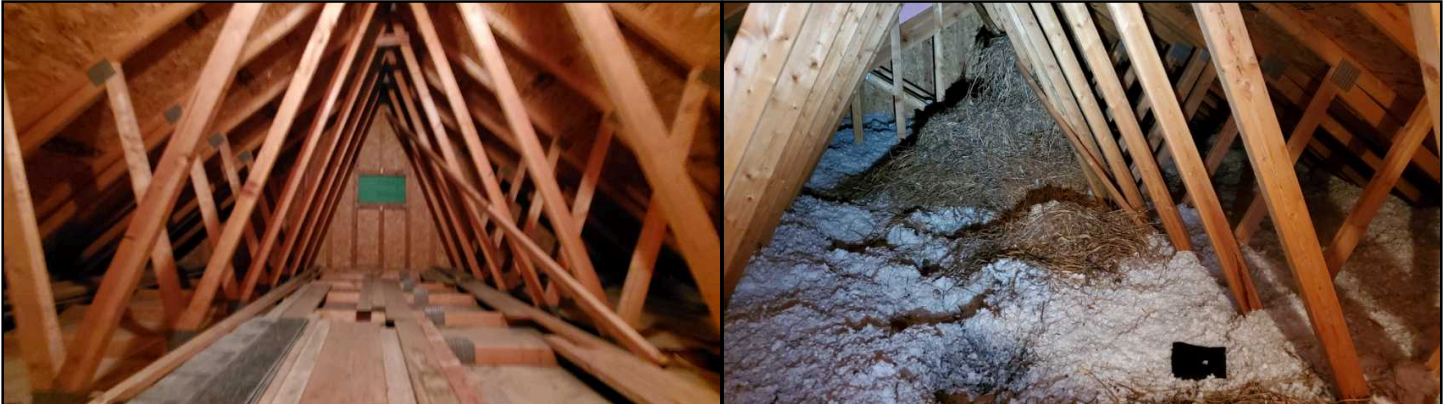
Garage Attic

- Large piles of grass/weeds in attic appears to be from wildlife activity. Recommend evaluation by pest control professional.

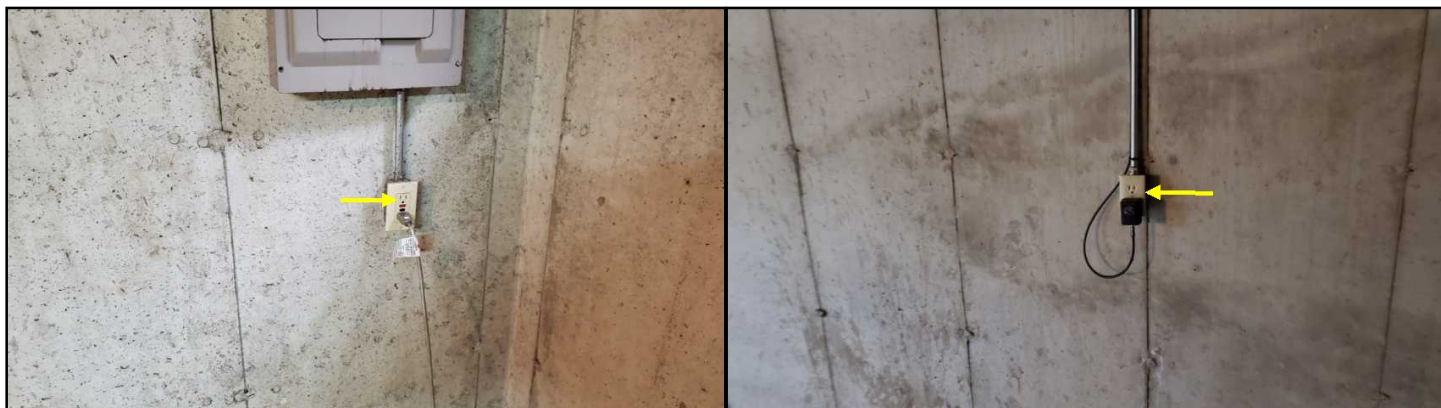
- Non-GFCI outlets located in the basement. Recommend licensed electrical contractor upgrade to GFCI protected outlets.
- GFCI protected outlet at main electric panel failed GFCI testing. Recommend repair by licensed electrical contractor.

Failed GFCI testing

Recommend GFCI protection

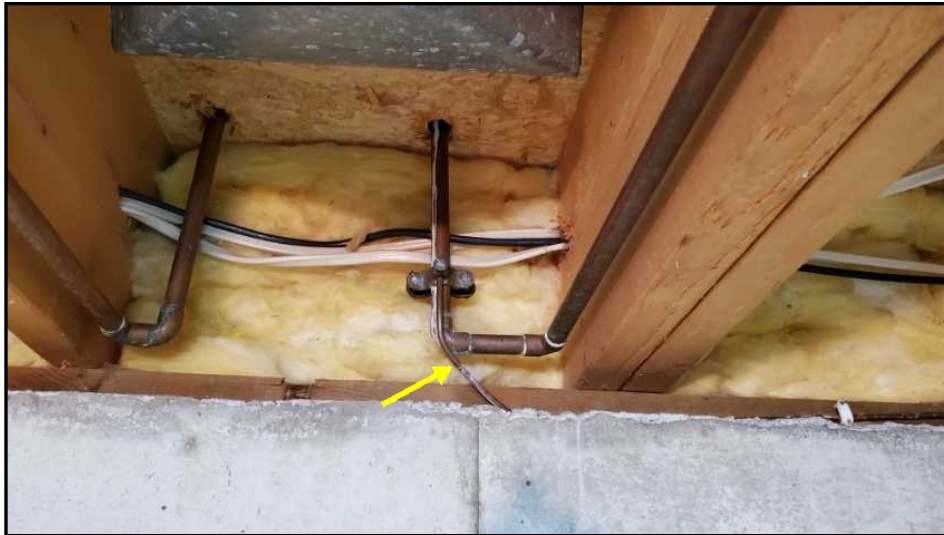
- One of the grounding electrode conductors ran to water pipe. Water service into home used plastic piping and this ground did not appear functional. Recommend evaluation/repair by licensed electrical contractor.

Ground to water pipe

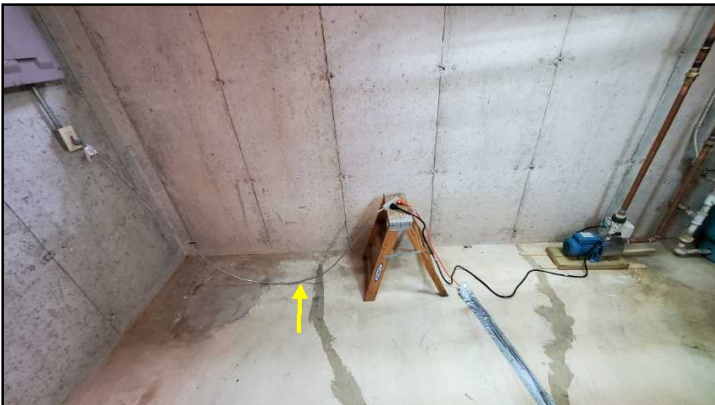
- Extension cord used as permanent wiring. Extension cords are intended for temporary use only and are not allowed to go through walls, floors, or cabinets. Recommend correction by licensed electrical contractor.

Extension cord

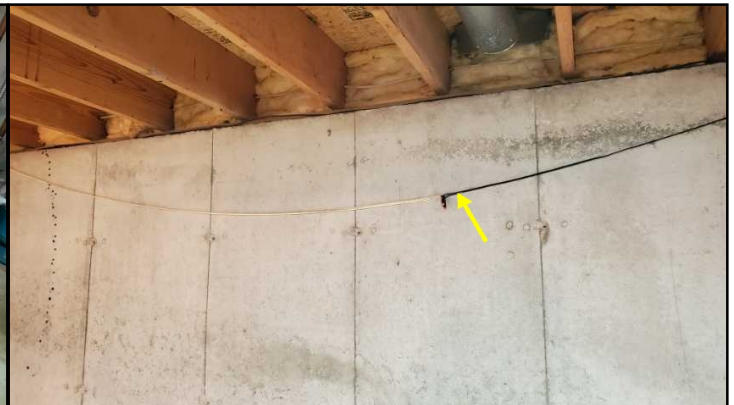
Appeared to be speaker wire

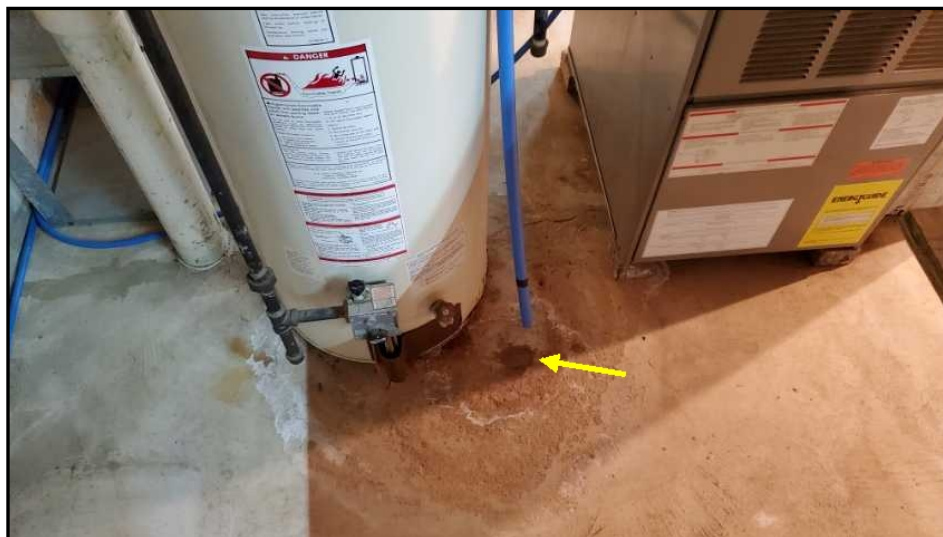
- **TPR valve** dripping. Recommend repair by licensed plumbing contractor.

TPR valve dripping

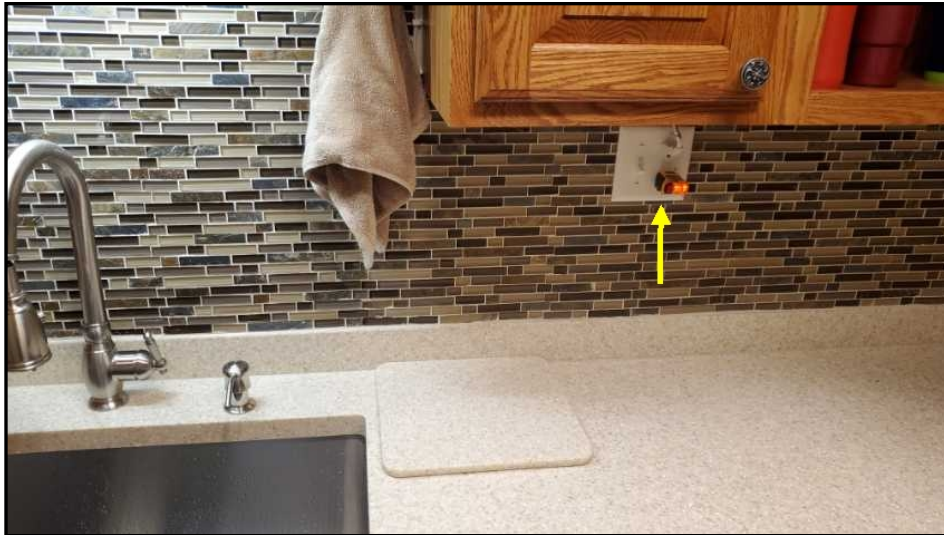
- Electric receptacle in laundry next to sink did not disconnect power when GFCI protection tripped. Recommend repair by licensed electrical contractor.

Failed GFCI testing

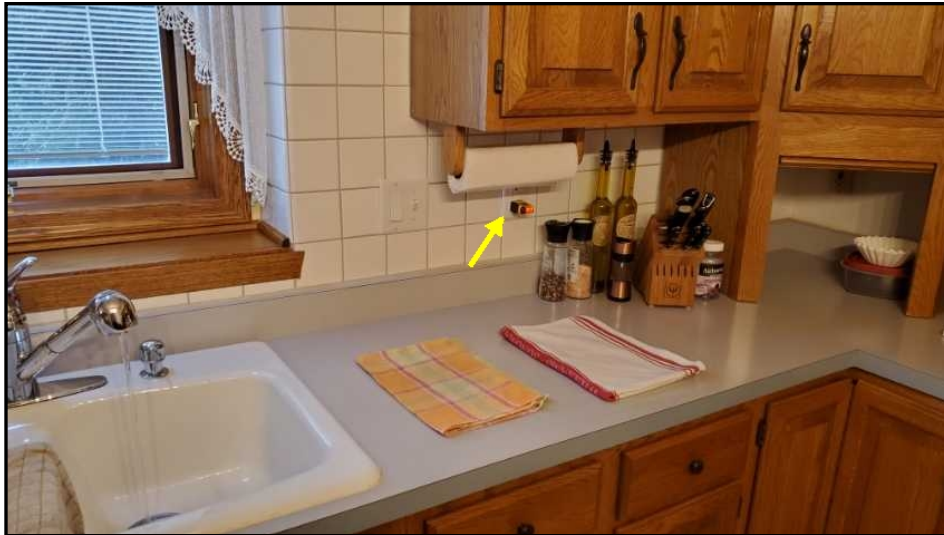
- GFCI protected outlet tripped but power remained on circuit. Recommend evaluation/repair by licensed electrical contractor.

Failed GFCI testing

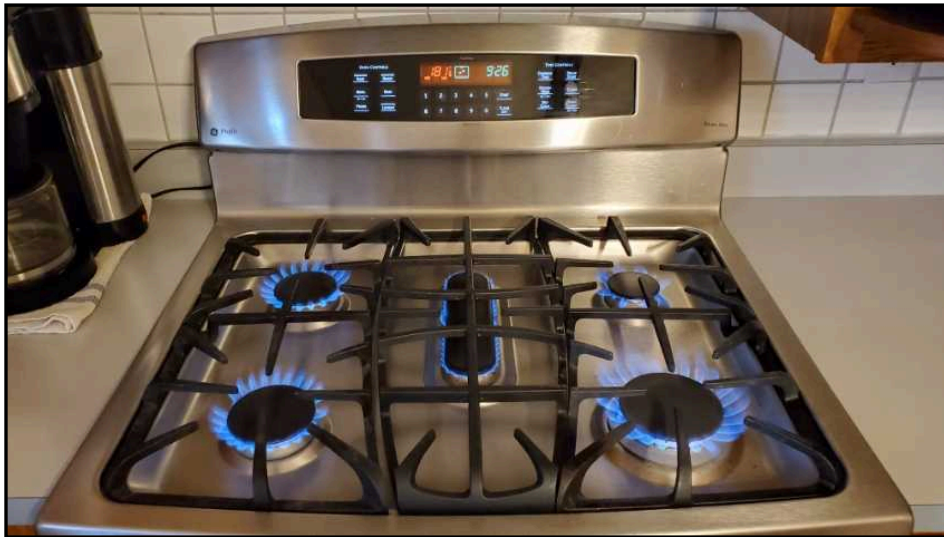
- The gas range responded to controls and appeared to be in serviceable condition at the time of the inspection. The self-cleaning and convection features if present were not tested.
- Anti-tip bracket not installed. Children have been known to step on the open oven door and have the oven overturn on top of them or hot pots slide off the cook top into them causing injury. Recommend installation of anti-tip bracket.

Gas range

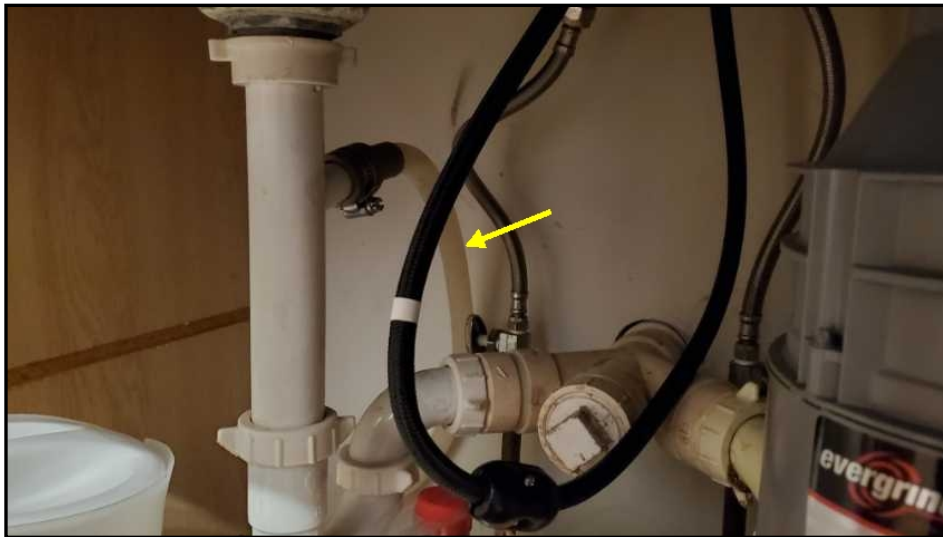
- The dishwasher was operated through a cycle and appeared to be in serviceable condition at the time of the inspection.
- The dishwasher drain line did not have an **air gap** device as required by modern standards. An air gap device prevents dirty water from back flowing into your dishwasher from the sink and can prevent contamination of the water supply under certain conditions. I recommend evaluation/repair by a licensed plumbing contractor.

Dishwasher drain line no air gap device

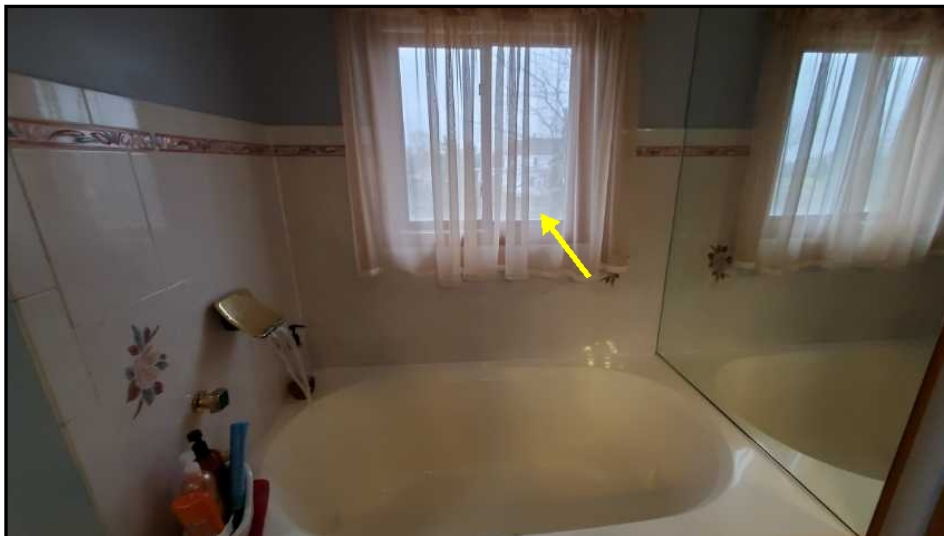
- Tub/shower unit operated as expected
- Walk in shower functioned as expected on day of inspection.
- A window in the bathroom which should have safety glass did not have the safety glass insignia. Windows in bathtubs and showers should have safety glass if the bottom of the window is less than 60 inches above a standing or walking surface. Recommend evaluation/correction by licensed contractor.

No tempered glass insignia

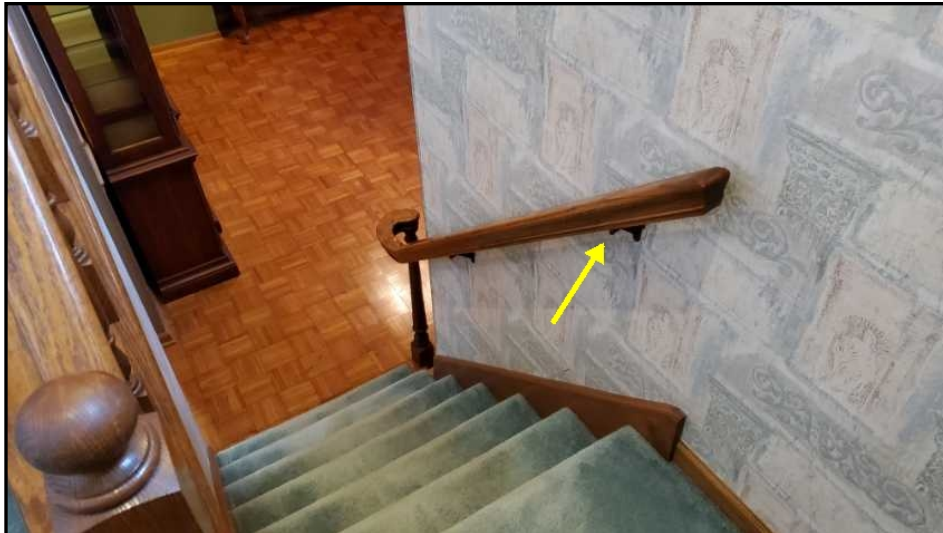
- Handrail loose at upper level stairway. Recommend repair by qualified contractor.

Handrail loose

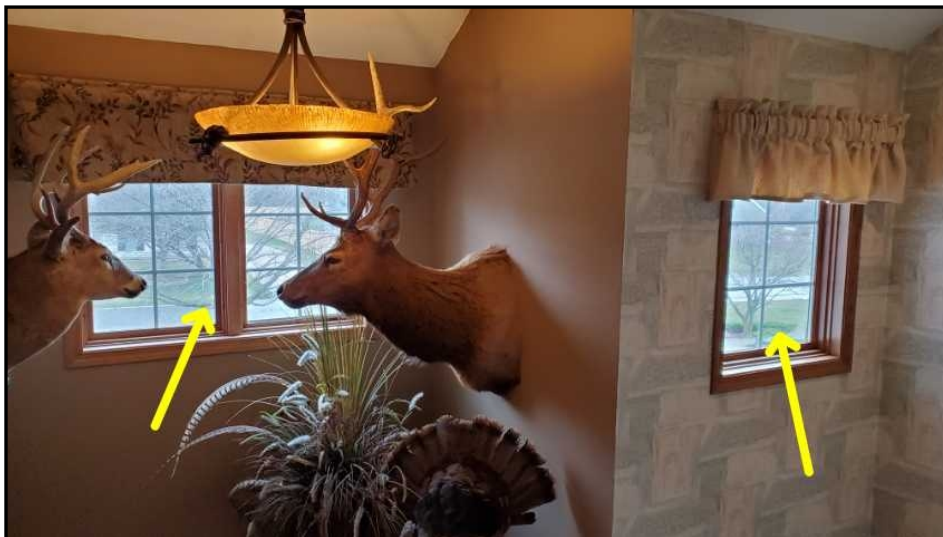
- Most windows in the home were wood and double hung style in satisfactory condition unless noted elsewhere in the report
- Windows upstairs had double-pane glazing in which condensation or staining was visible at the time of the inspection. This condition indicates the seal between the two panes of glass has failed. The window/s should be repaired or replaced as necessary.

Failed double pane windows

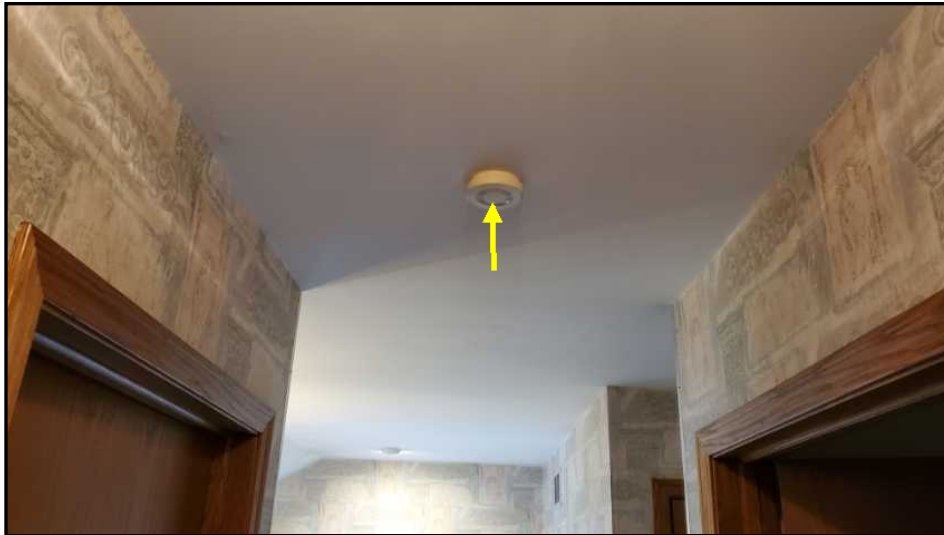
- The National Fire Protection Agency recommends smoke alarms be replaced every ten years. Smoke alarms should have either a build date or a manufacture date on the back side of the unit. Once a year you should go through the home and check the dates. Any units older than 10 years should be replaced.
- Smoke alarm failed testing. Recommend repair/replacement

Failed testing

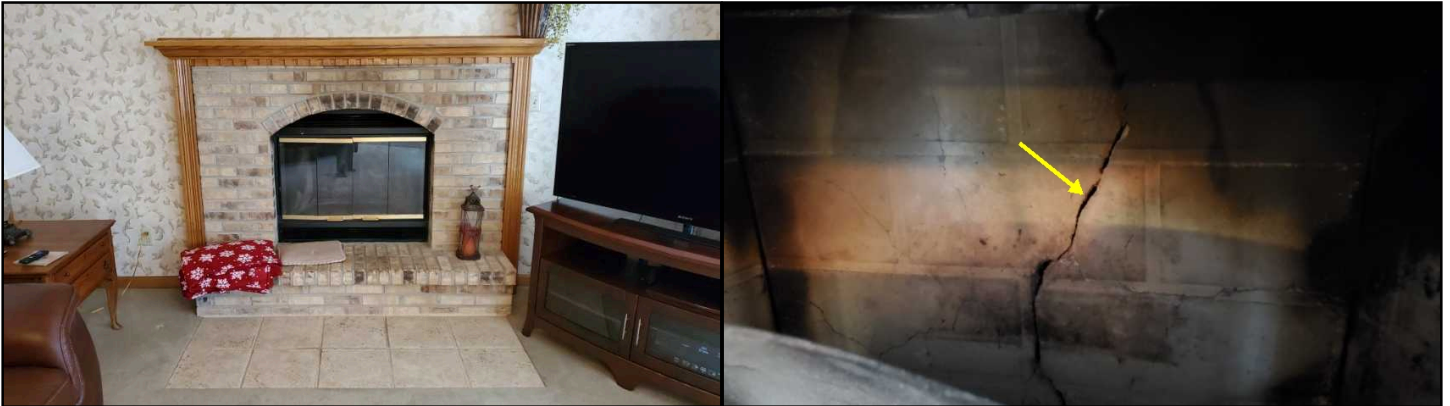
- The family room had a wood-burning fireplace. Inspection of wood-burning fireplaces typically includes visual examination for the following components:
 - Adequate hearth
 - Presence of ember screen or doors
 - Firebox condition
 - Operable damper
 - Flue condition
 - Exterior condition
- The National Fire Protection Association recommends having your chimney inspected annually to ensure its safe operation. Homeowners should have regular annual chimney inspections to ensure that everything with your chimney and fireplace is in working order, safe to use, and operating correctly. Recommend evaluation by certified chimney sweep before first use and annually thereafter.
- Refractory lining the wall of the firebox of the wood-burning fireplace in the family room was cracked and may need repair. The Inspector recommends evaluation/repair by a certified chimney sweep.

Cracked refractory
