Advanced Property Inspections

Home Inspection Report

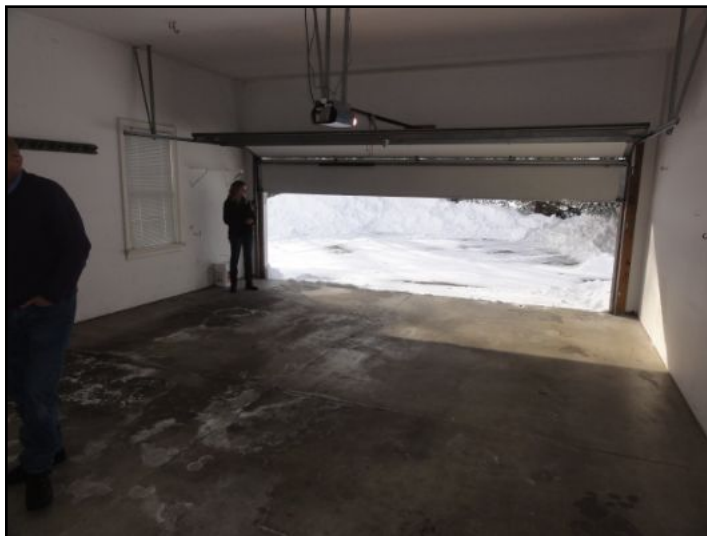
Garage

Observations: The home had a two-car attached garage.

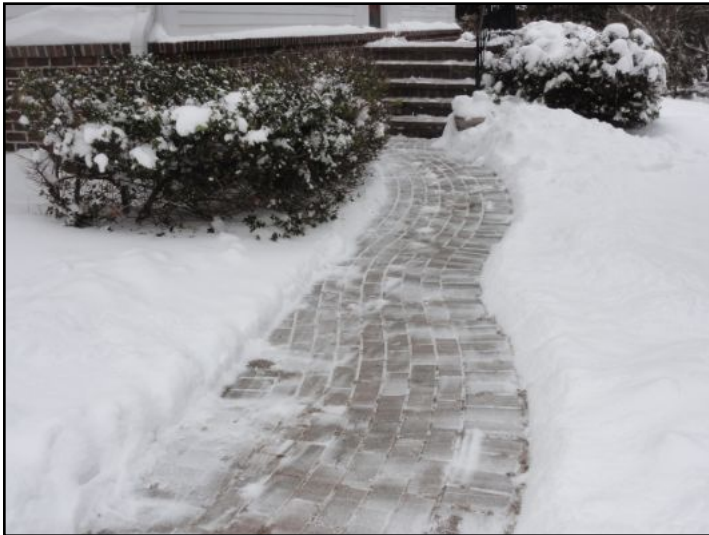
Sidewalk

Inspector Comments No visible concerns on day of inspection.

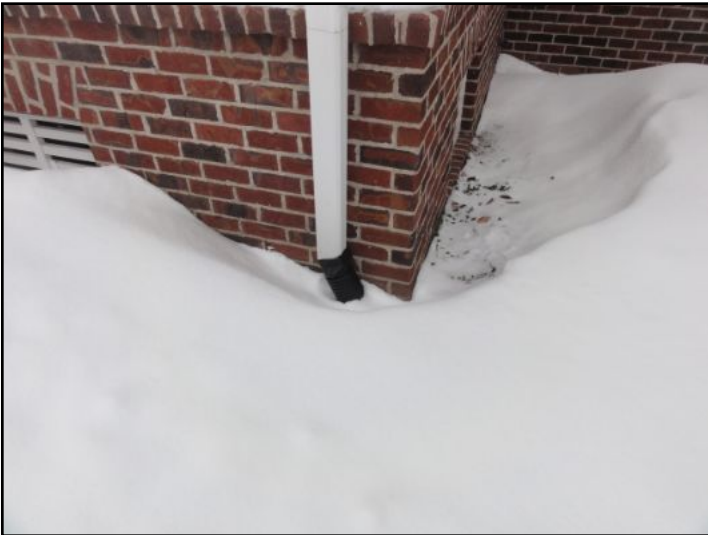
- The downspouts were drained to underground drain piping. Underground drain piping is outside the scope of a normal home inspection.
- There does not appear to be a kickout flashing where the gutter meets the wall. This allows water to run around the end of the gutter and down the fascia or wall. Recommend correction by licensed roofing contractor.

Down spouts discharge underground

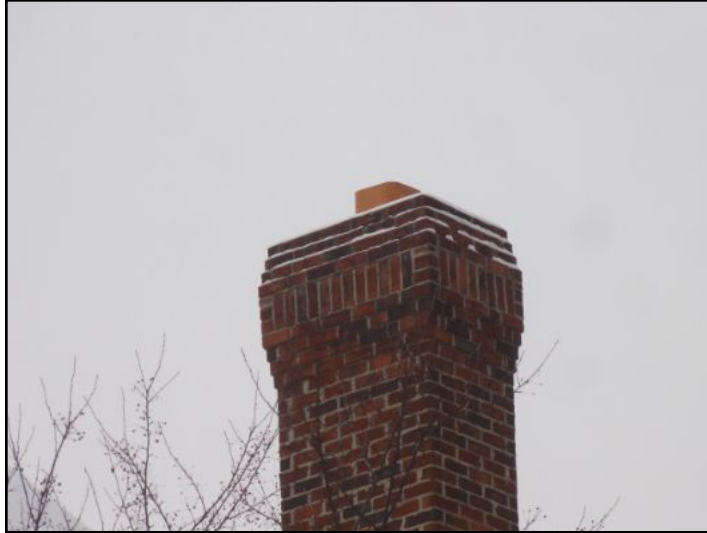
Chimney

- The chimney exterior was brick and in good condition at the time of the inspection.

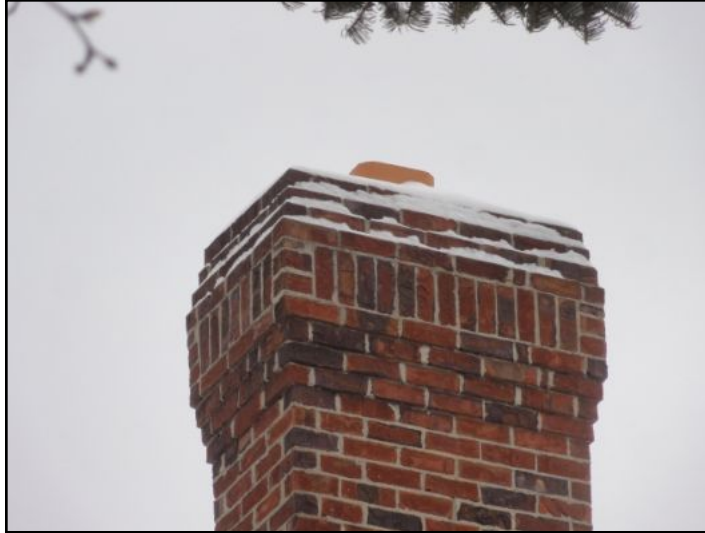
Chimney

- The chimney exterior was brick and in good condition at the time of the inspection.

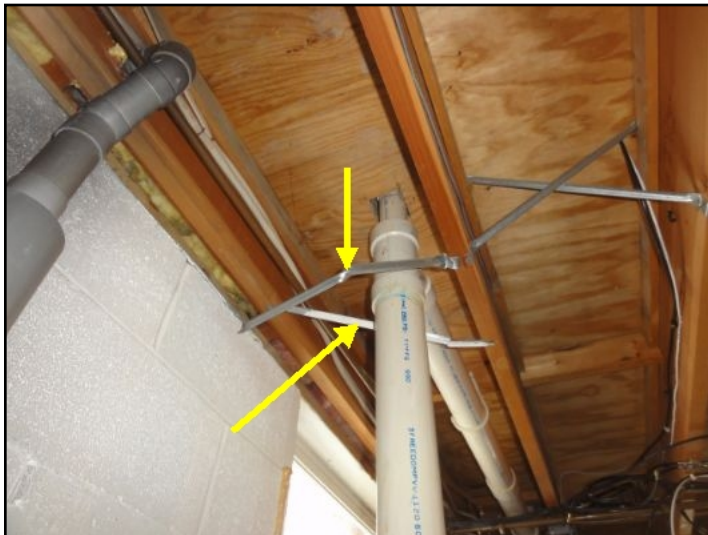
- The main beam was steel
- The beam support posts were steel.
- A couple floor joist braces were partially removed, probably for plumbing access. I recommend these braces be replaced.

Floor joist braces removed

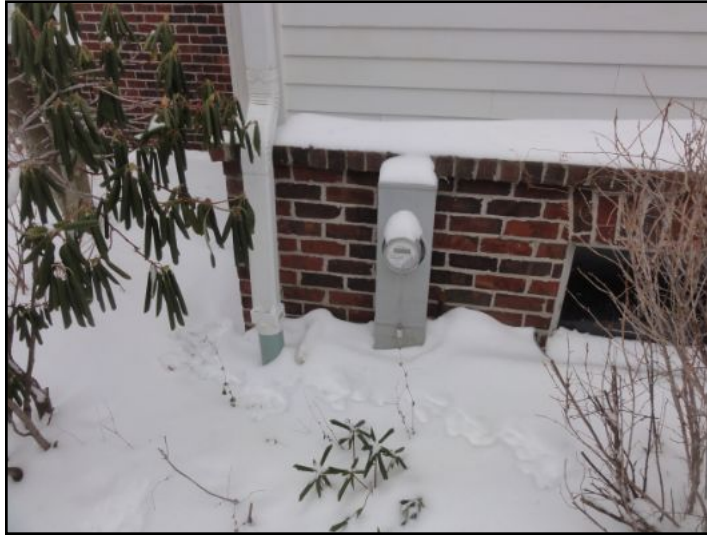
Observations: The electrical service was underground.

Underground electric service

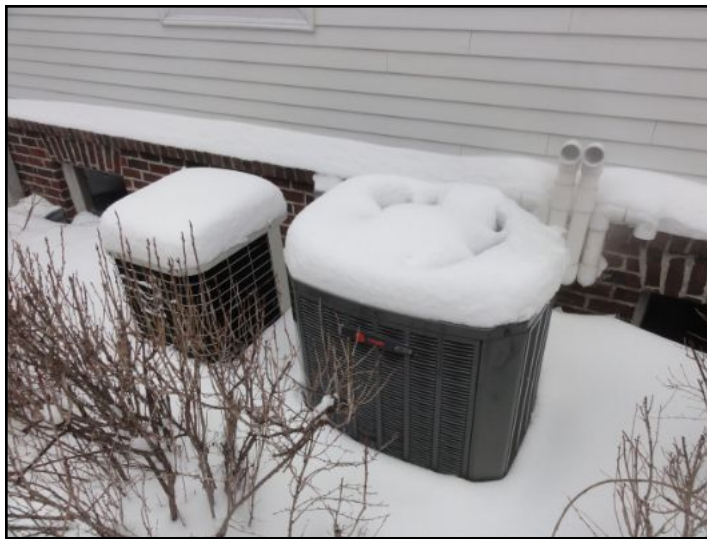
AC units

Inspector Comments Central heat and air conditioning are provided by dual systems, consisting of a furnace with evaporator coils that are located in the basement, and condensing coils that are located on the outside of the home. Central air not operated because outdoor temperature was below 65F. Operation below 65F may damage the compressor.

Manufacturer Trane
Age 3 years
Capacity 3 tons
Manufacturer Bryant
Age Over 20 years
Capacity 2.5 tons

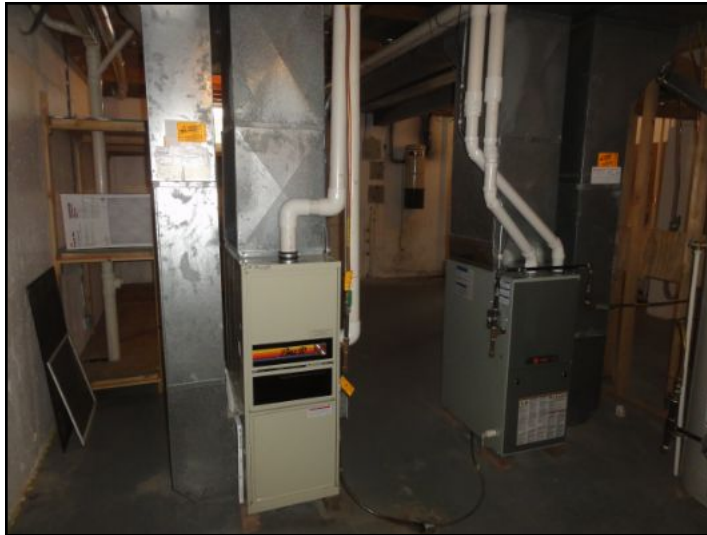
Furnaces

Inspector Comments Both furnaces responded adequately to the call for heat.
 Age Over 20 years.
 Capacity 80,000 btu's.
 Manufacturer: Bryant
 Age 5 years.
 Capacity 80,000 btu's.
 Manufacturer: Trane

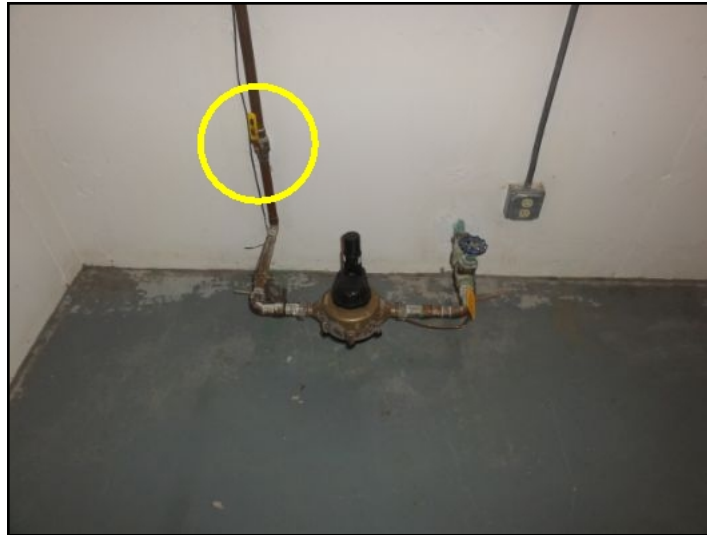
Main water shutoff valve

Inspector Comments The main water supply pipe appeared to be 1" copper. The main water supply shut-off was located in the basement. Although the main water supply shut-off valve was not operated at the time of the inspection it was visually inspected and appeared to be in serviceable condition.

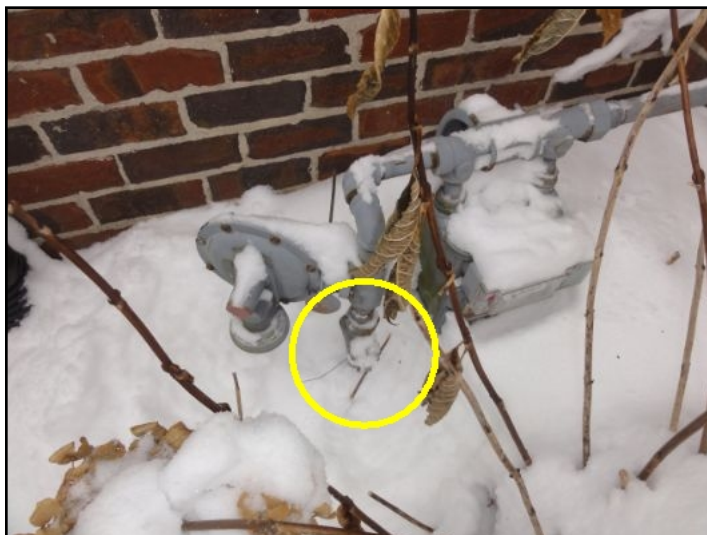
Main gas shutoff valve

Inspector Comments Shutoff valve present. See picture. We do not function check any fuel valves. If you smell natural gas in your home act fast. Don't delay - get completely away and call your natural gas provider. If you don't know that number call 911. Gas supply piping is black iron and copper. The visible gas lines appeared to be in serviceable condition at the time of inspection.

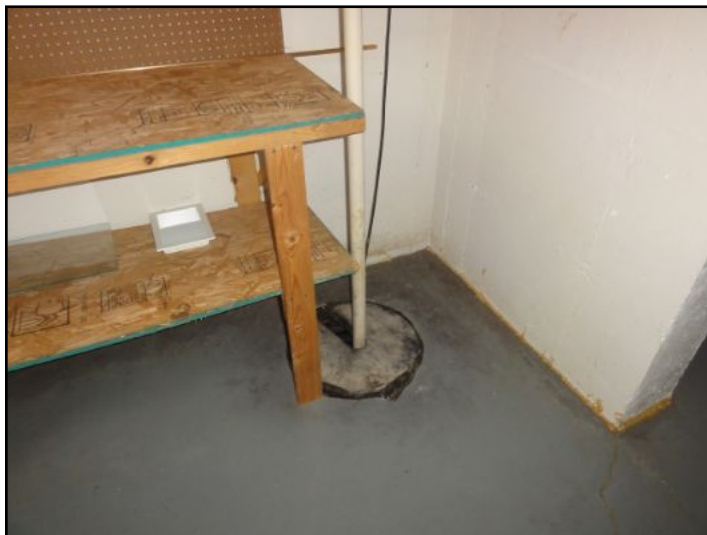
Sump Pump

- I tested your pump by removing your cover and slowly poured water into the sump tank. I then watched for the float to rise and trigger the pump. Once the pump engaged, the water level quickly lowered and the float shut off the pump.

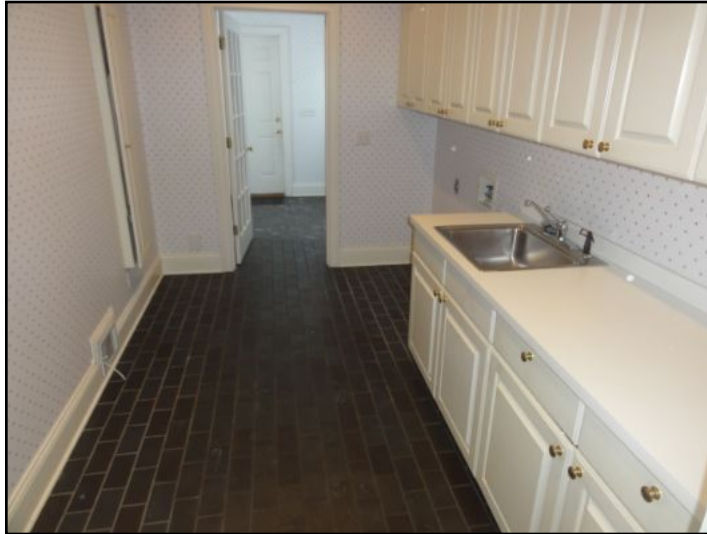
Laundry Area

Observations: The laundry room is on the main living level. When connecting the washer you might consider replacing rubber hoses with braided stainless to safeguard against ruptured hoses. It's also a good idea to install a drip tray under the washing machine.

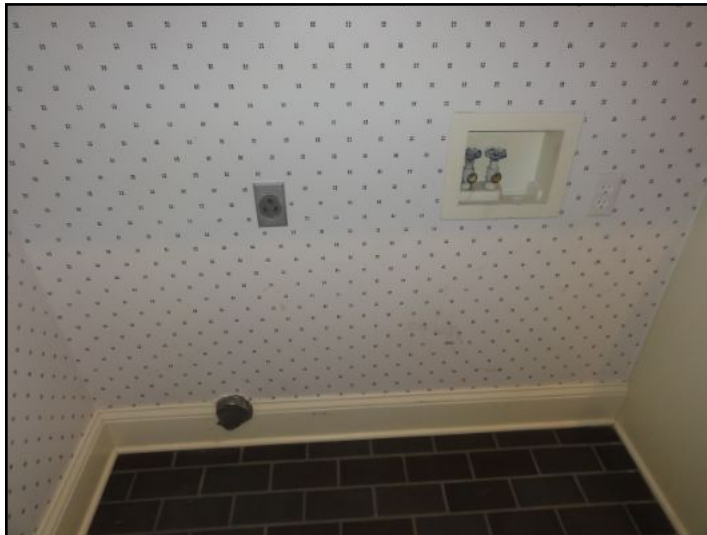
Plumbing connections for washer

Inspector Comments Comments: Inspected - Not operated
Location: Basement
Materials: Copper supply, PVC drain.

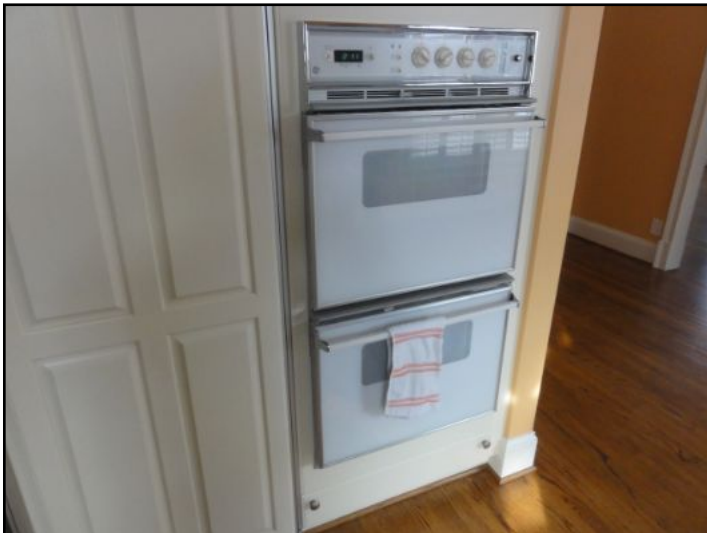
Double oven

- The gas cooktop responded to all controls and appeared to be in serviceable condition at the time of the inspection.
- The electric ovens responded to controls and appeared to be in serviceable condition at the time of the inspection. The self-cleaning feature was not tested

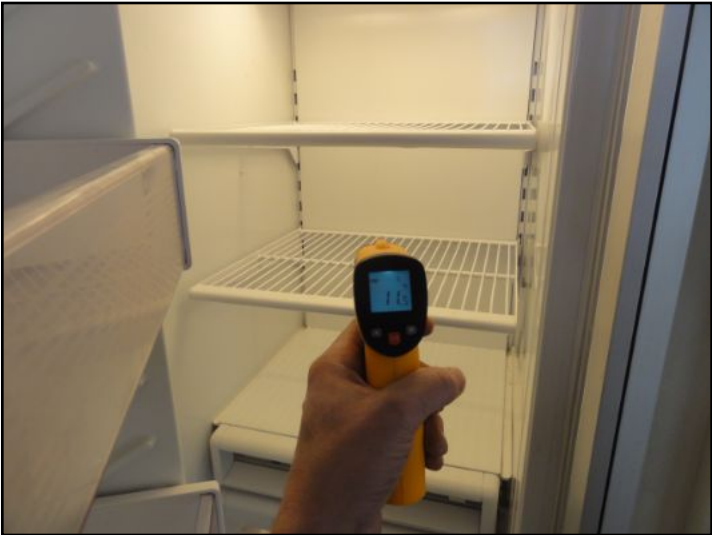
Freezer

- Refrigerator inspected and functioned as intended.

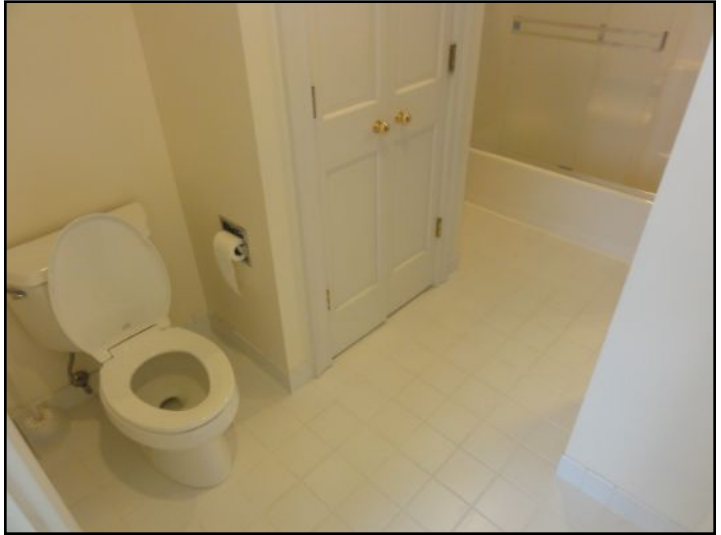
Bathroom upstairs

- This bathroom sink appeared to be in serviceable condition at the time of the inspection.
- The bathroom sink faucet appeared to be in serviceable condition at the time of the inspection.
- The bathroom cabinets and counter top were serviceable at the time of the inspection.
- The sink in this bathroom had an inoperable stopper.

Faucet stopper needs repair

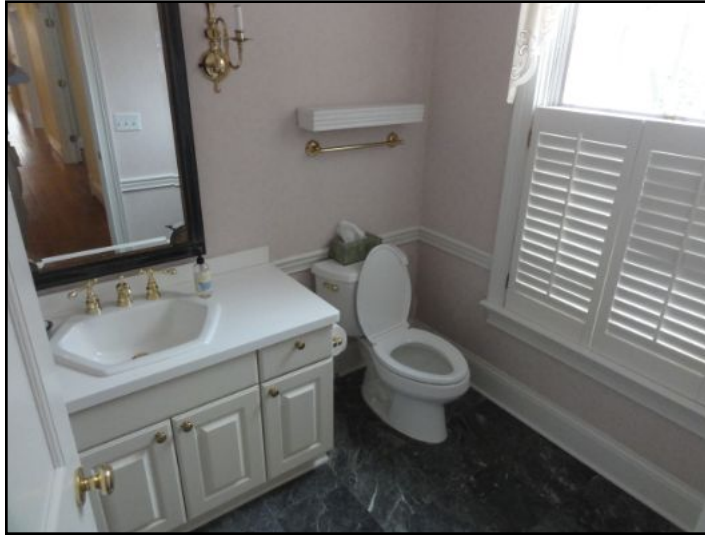
Half bath

- This bathroom sink appeared to be in serviceable condition at the time of the inspection.
- The faucet at this bathroom sink was inoperable at the time of the inspection. Recommend correction by licensed plumber.

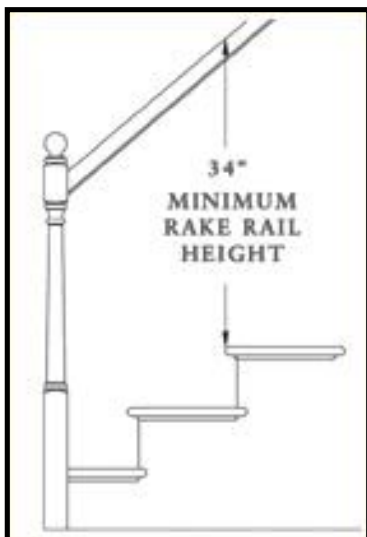
Stairway to upper level

- Inspector Comments** Upstairs handrail loose. Handrails should be able to withstand a 200 pound load in any direction. Recommend correction buy licensed contractor. Handrail doesn't meet minimum height requirement of 34 inches from stair toe to top of handrail. Recommend consultation with licensed contractor to evaluate options.

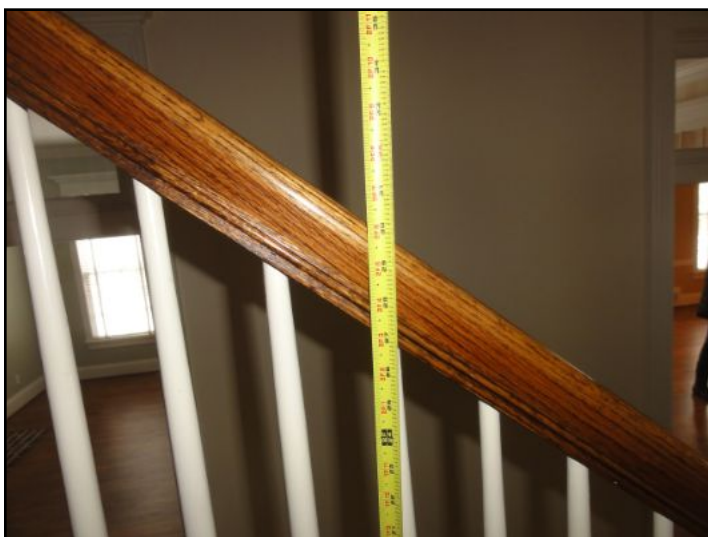
Handrail 30" tall

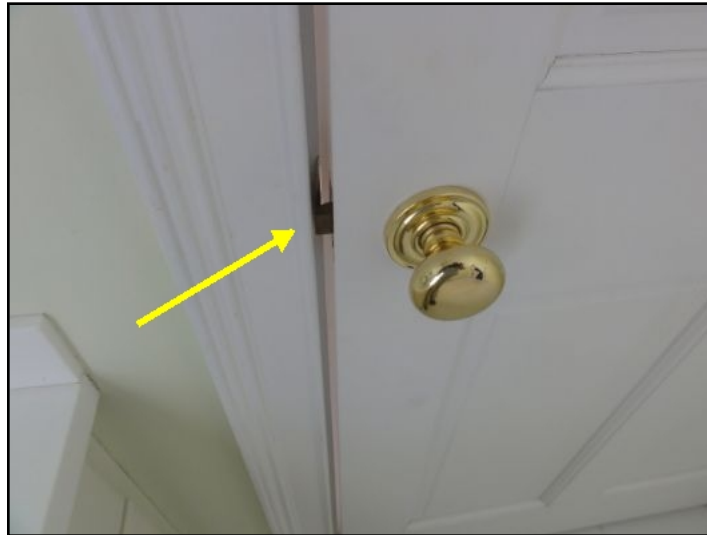
- The latch of the door to this bedroom did not align with the hole in the strike plate and did not hold the door closed. This door will need adjustment to operate properly.

Strike plate needs adjustment to latch door
